Pocosin Lakes National Wildlife Refuge Clayton Blocks Seepage Monitoring

Introduction

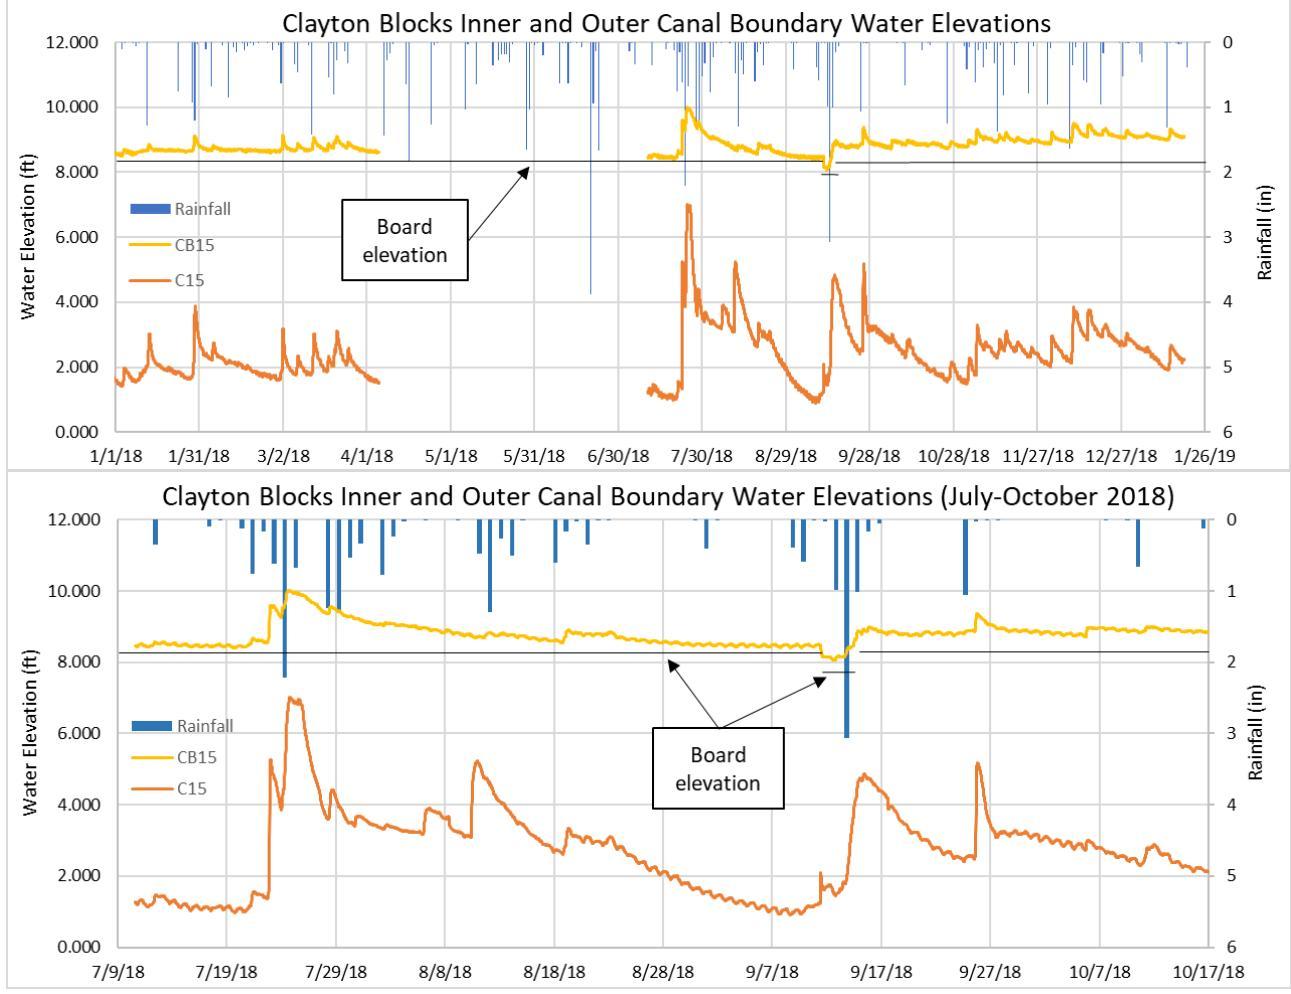
Water levels and flow were compared at C15 and CB15 and at C14 and CB14 to check for possible of seepage through the separation berm (**Figures 3 and 4**). The water elevation of the outer C canal is consistently 4-6 feet lower than the inner CB canal (Refuge WCS). Throughout the study period, the water surface elevation at C15 recedes more rapidly than at CB15, indicating that there is not a substantial amount of seepage through the berm. On average, in the 48 hours following a storm event, the water elevation at C15 drops 71% more than the water level at CB15. In the following 48 hours, from 48 to 96 hours after a storm, the water level at C15 drops 65% more than the water level at CB15.

Figure 3. Water elevations at Clayton Blocks inner (CB15) and outer (C15) canal boundary water control structures for the study duration (top) and a period of heavy rainfall (bottom) at PLNWR.

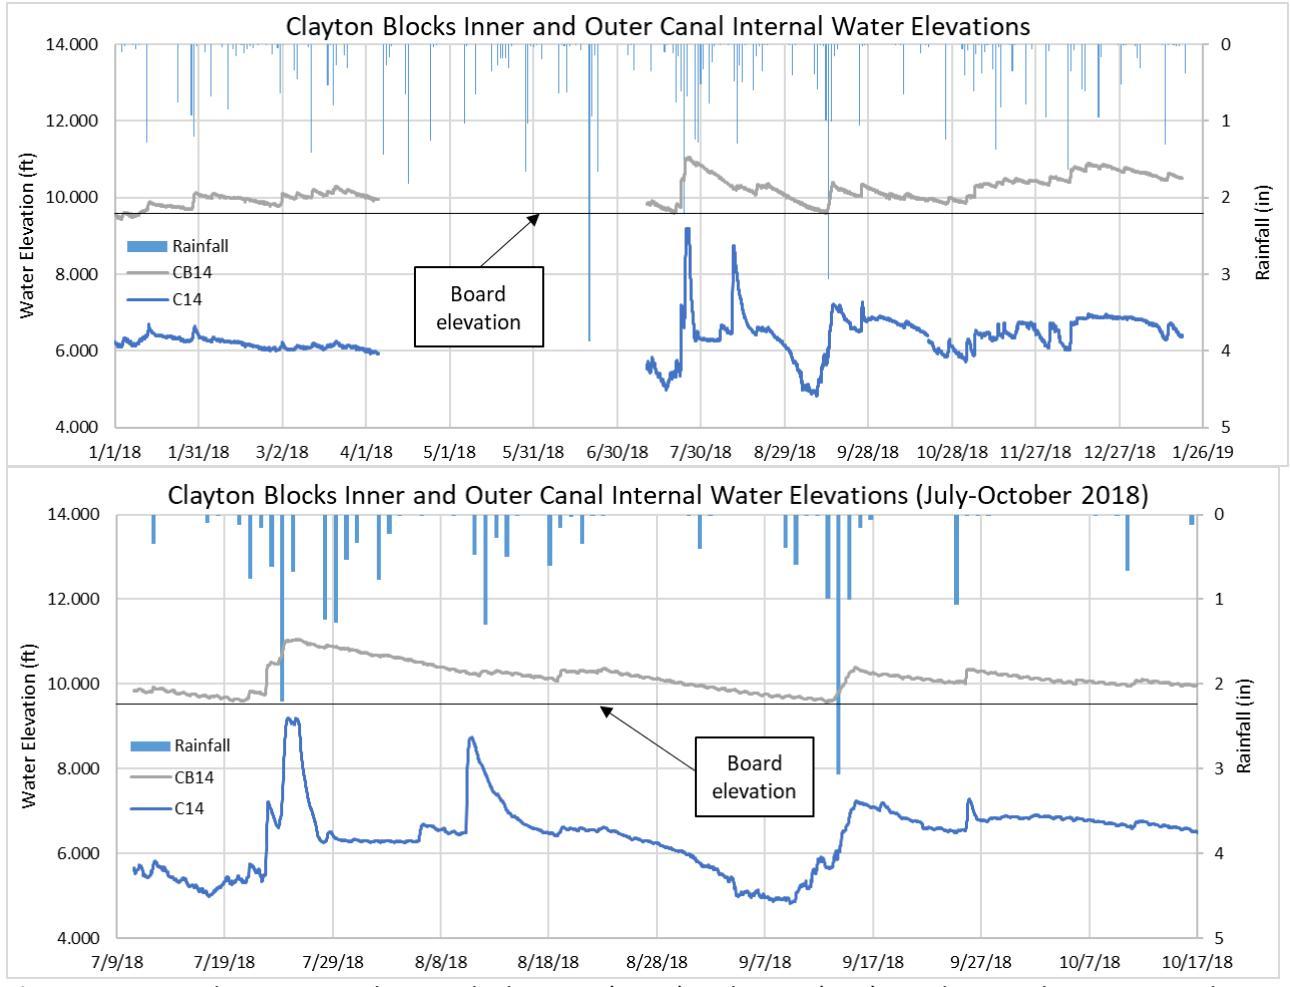
Figure 4. Water elevations at Clayton Blocks inner (CB14) and outer (C14) canal internal water control structures for the study duration (top) and a period of heavy rainfall (bottom) at PLNWR.

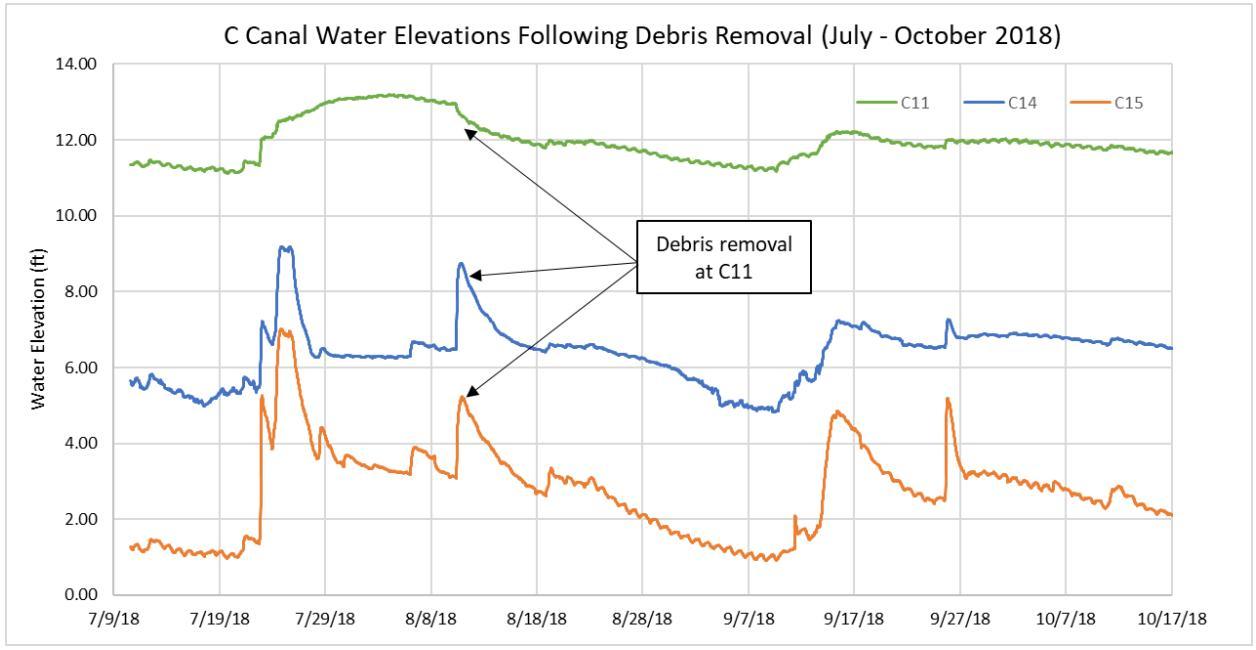
On August 10, an increase in water elevation was observed at the C14 and C15 WCS but not at CB14 or CB15. This is likely caused by the clearing of debris at the C11 WCS, resulting in lower water levels at C11 and a temporary increase in water level downstream at C14 and C15. The CB canal, which does not receive water from upstream of C11, was unaffected (**Figure 5**).

Figure 5. Outer C Canal debris removal and resulting downstream water level changes at PLNWR.

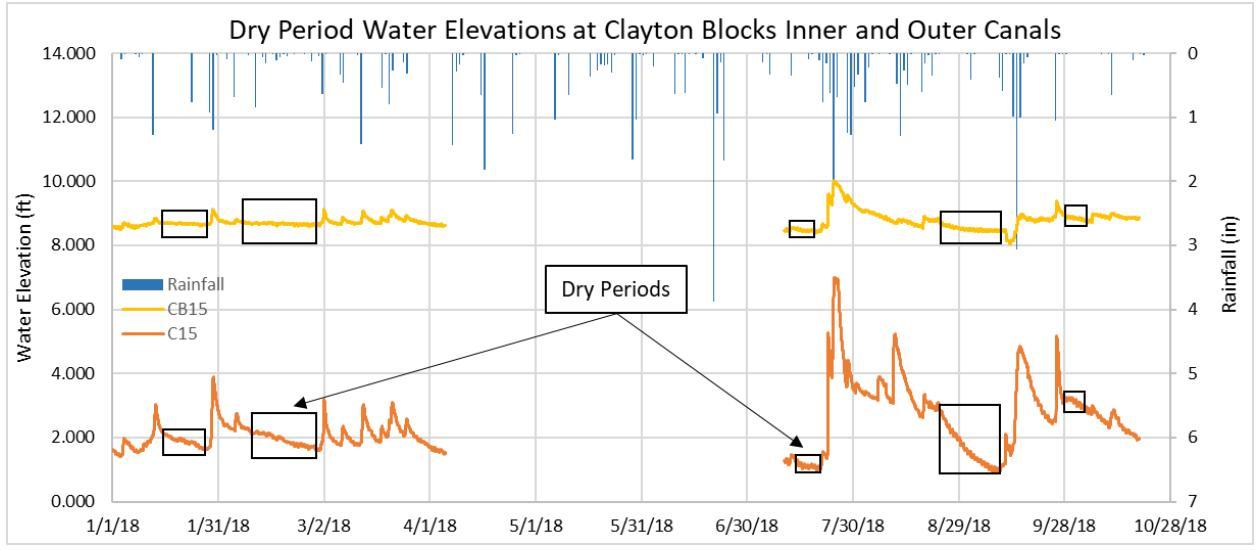
During drier periods, water elevations at C15 declined more than at CB15. Water levels at C15 dropped an average of 24% during periods of little to no rain, while levels at CB15 dropped an average of only 1% (**Figures 7 and 8**). The WCS at C15 has two risers to control flow downstream of the Refuge, each with three bays. As of January 2019, one riser contains boards in all three bays that reach nearly to the top of the structure. The second has boards in two of the three bays but no boards in the last bay. This uncontrolled flow through the last bay of this riser likely accounts for some of the decrease in C15 water elevation during times of little to no rainfall.

Figure 8. Water elevations during dry periods of little to no rainfall at Clayton Blocks inner and outer canal boundary water control structures at PLNWR.

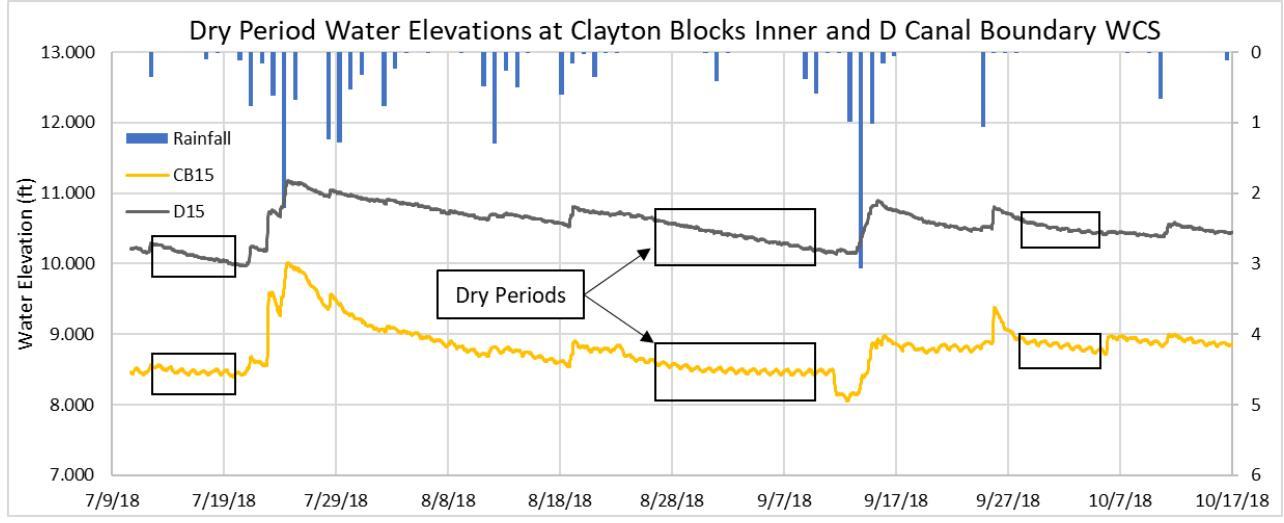
Water elevation was compared between the CB15 and D15 WCS during dry periods from July to October 2018. Dates from January to April were not included because of the board configuration changes and resulting water level changes caused by the De-Hoog Road project. Both the CB15 and D15 WCS are located at the boundary between refuge and private farmland, and both structures use boards to control upstream water level. During these three dry periods, water elevation declined by an average of 2.6% at D15 and 1.2% at CB15 (**Figures 9 and 10**). Both structures exhibit only a small decline in water level, especially compared to C15. The similar drawdown rates between CB15 and D15 indicate that there is little to no seepage through the separation berm between the C and CB canals.

Figure 10. Water elevations during dry periods of little to no rainfall at Clayton Blocks inner canal boundary and D canal boundary water control structures at PLNWR.
