Pocosin Lakes National Wildlife Refuge Clayton Blocks Seepage Monitoring

Introduction

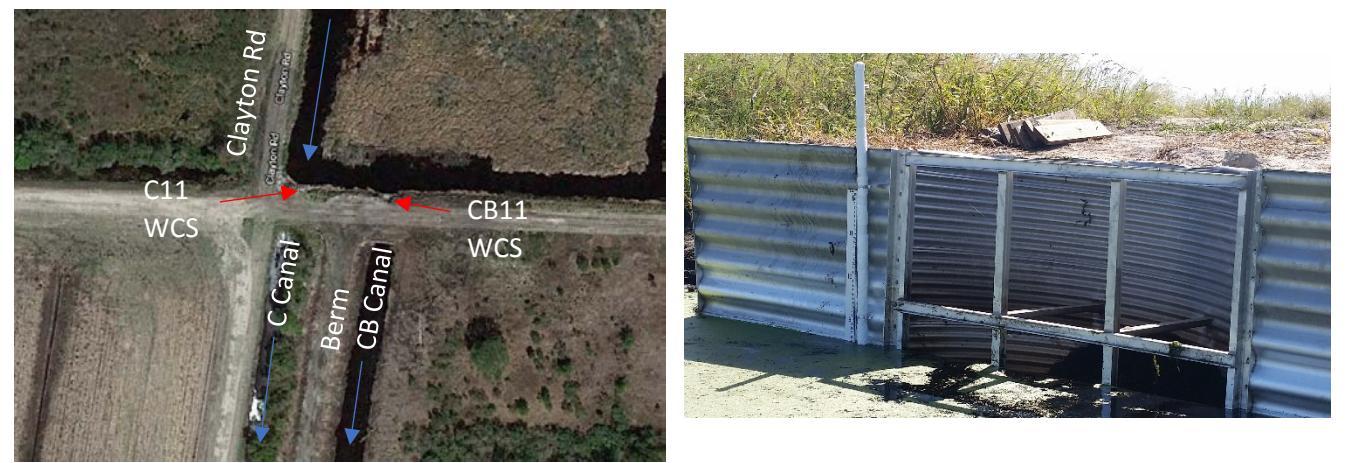
Figure 1. Aerial imagery of Clayton Blocks inner and outer canals and berm (left) and an upstream view of a water control structure and monitoring well installed in the Clayton Blocks inner canal at PLNWR (right).

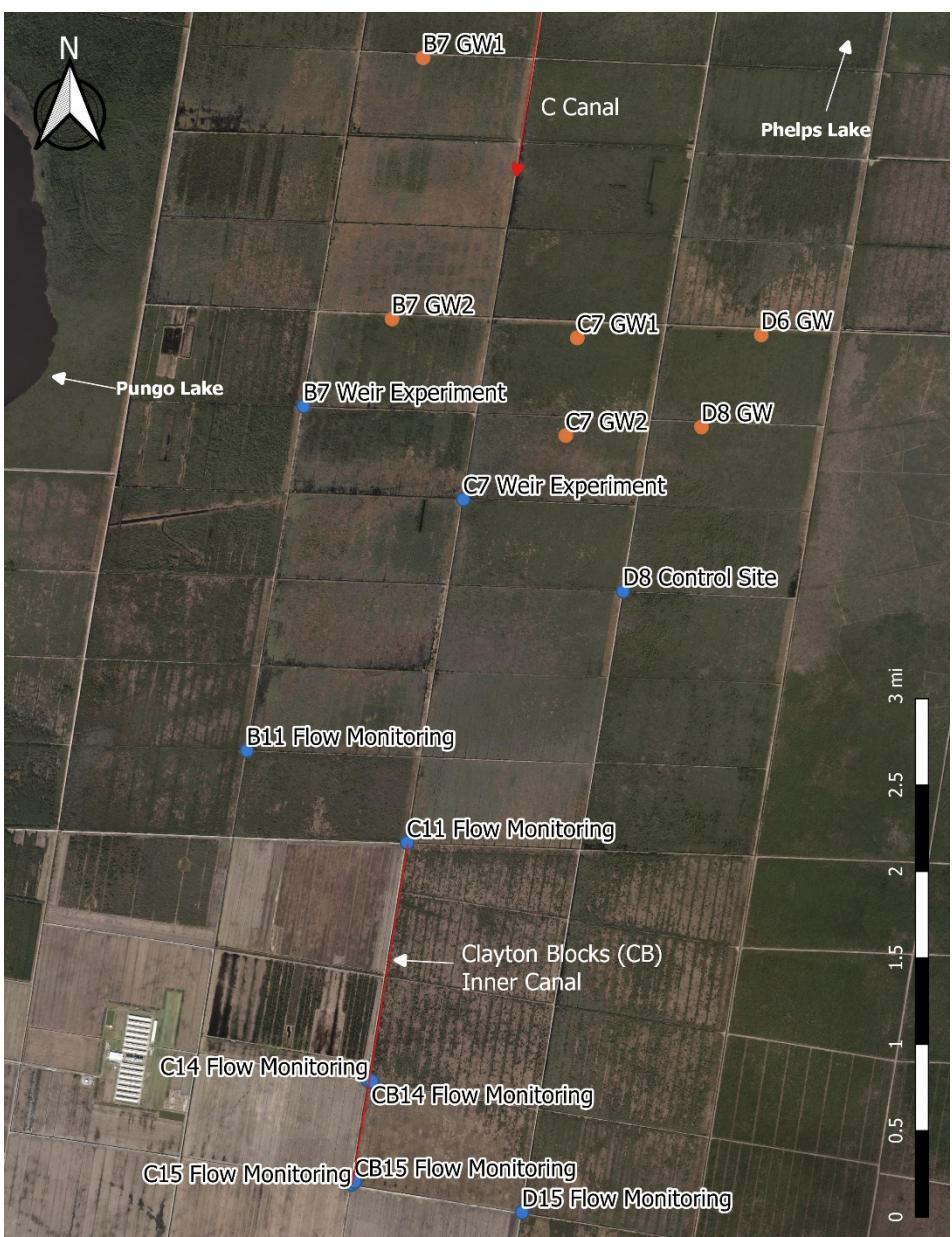
Flow and water level monitoring wells were installed at several WCS in and around the Clayton Blocks Restoration Project in October of 2017 (**Figure 2**). The monitoring design involved water level readings at the interior Clayton Blocks WCS and along the shared border canal. Water levels in the managed wetland restoration areas can be directly compared to the adjacent freely draining outer canal. Monitoring equipment was surveyed with a survey grade GPS unit and staff gages were installed to convert all measurements to referenced elevations. After a short period for equalization, data collection was initiated on January 1, 2018. Data was collected at WCSs C11, C14 and C15 in the outer C canal as well as CB14 and CB15 in the inner CB canal. No flow was recorded over the CB11 WCS during the study period. Stage measurements are recorded every 30 minutes and collected from the refuge quarterly; data is corrected using field measurements of water elevation at the time of download.

Figure 2. Water table and flow monitoring stations at PLNWR.
