FINAL REPORT

Stormwater BMPs and LID measures to protect coastal waters near Eagle Point Golf Club

Submitted to: New Hanover County Planning Department

Submitted by: NCSU Biological and Agricultural Engineering Department

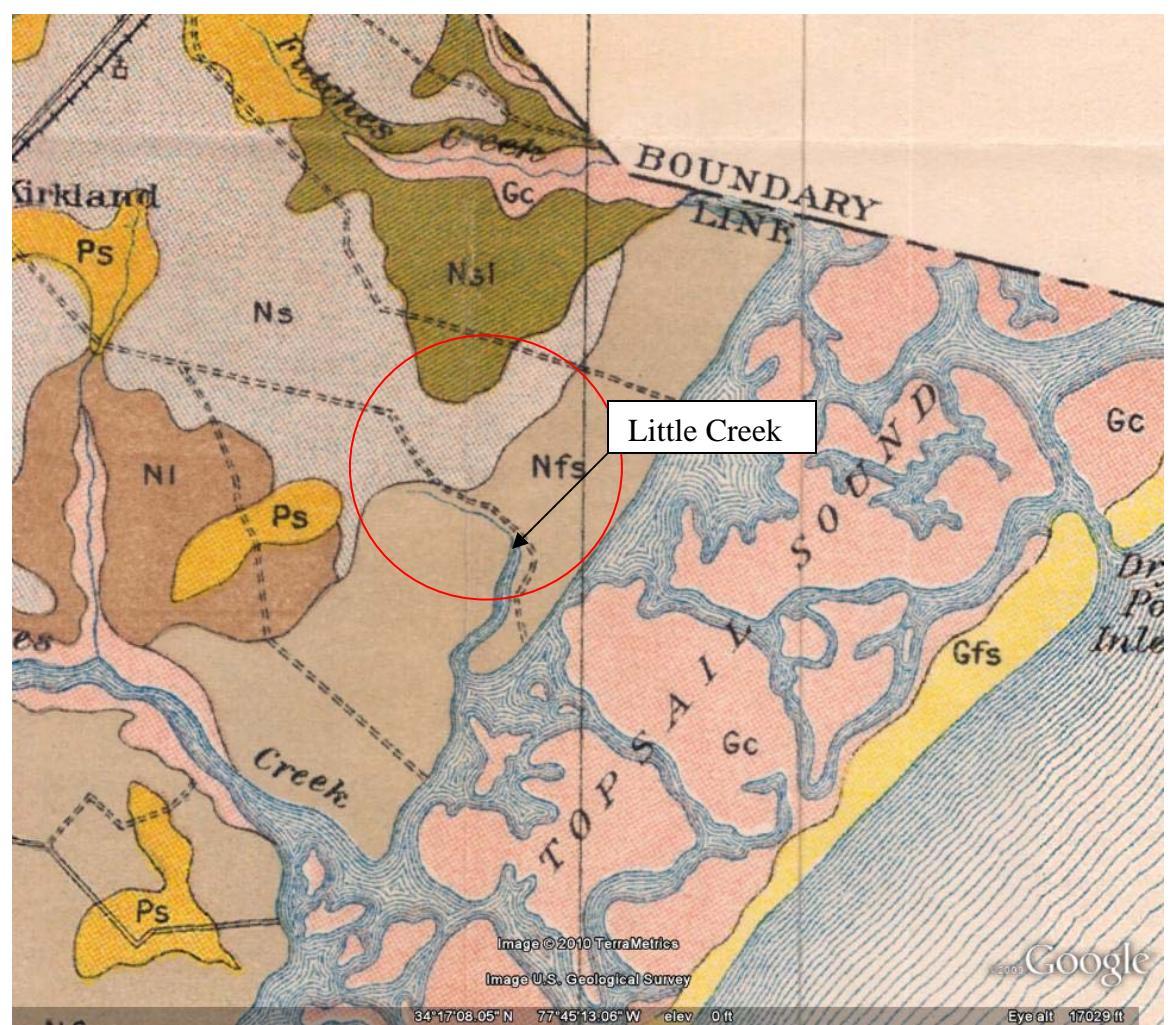
Figure 1. Historic Soil Map – 1906. Showing Little Creek and the drainage feature through the course. Source: UNC NC Maps website - http://www.lib.unc.edu/dc/ncmaps/index.html

In addition, historical aerial photos of the site and soils data were examined (Figure 1 and 2). A historical perspective can provide a reference to the types of changes that may have led to possible water quality or flow issues. The majority of the area is mapped as Kenansville fine sand. This soil type is extremely sandy with high infiltration rates. The soil description indicates that ponding is not a problem and drainage issues are rare. Due to the high infiltration capacity of the surrounding soils, many ponds in the area need a liner in order to hold water. An aerial photo from 1993 (Google Earth – Figure 2) shows a single main drainage feature through the site, with what may be high ground on each side that had been cleared or farmed in the past. The amount of open area seen is a suggestion of the sandy and limited fertility of these soils.

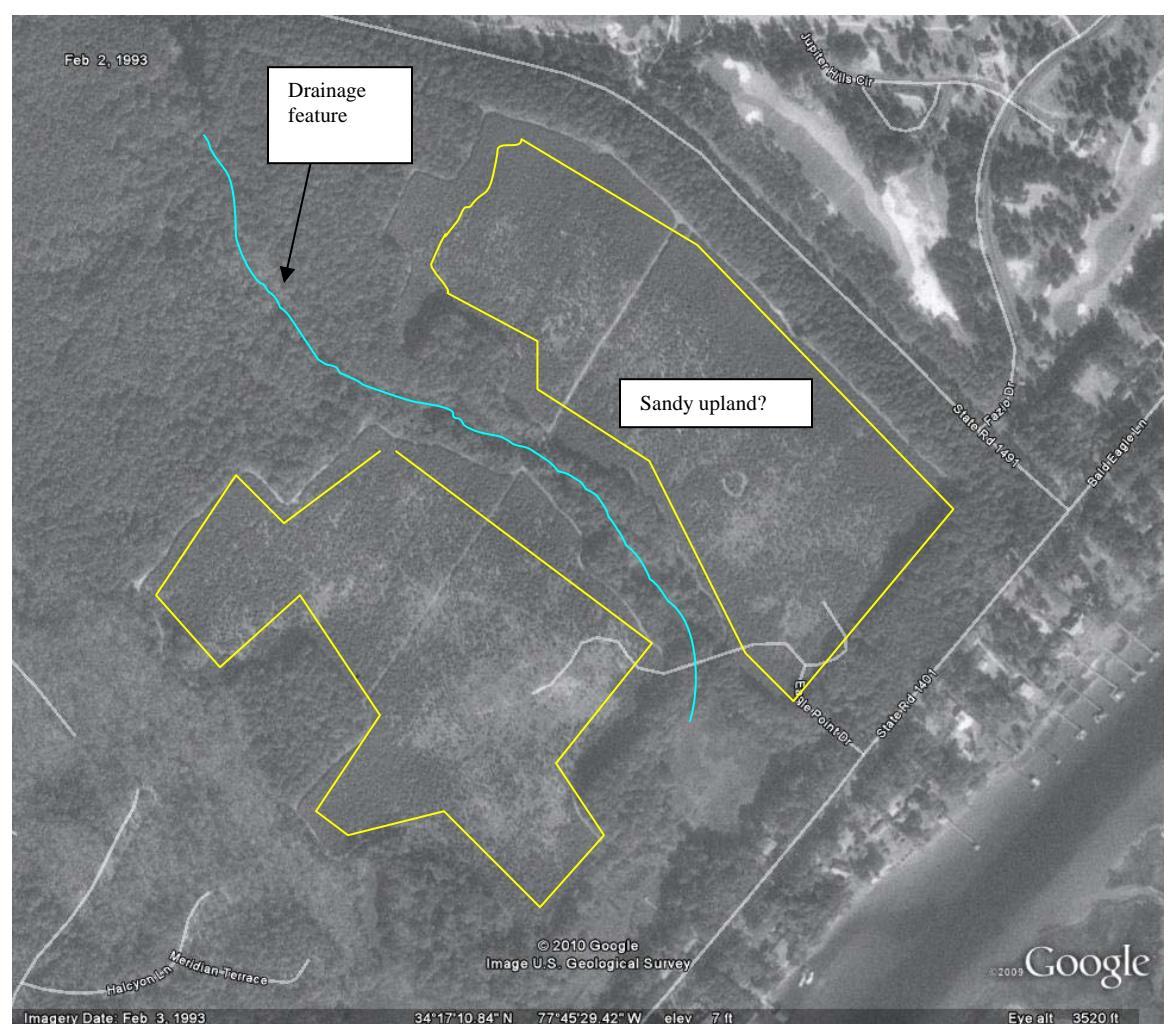
Figure 2. 1993 satellite imagery of EPGC prior to construction (Google Earth, 2010).

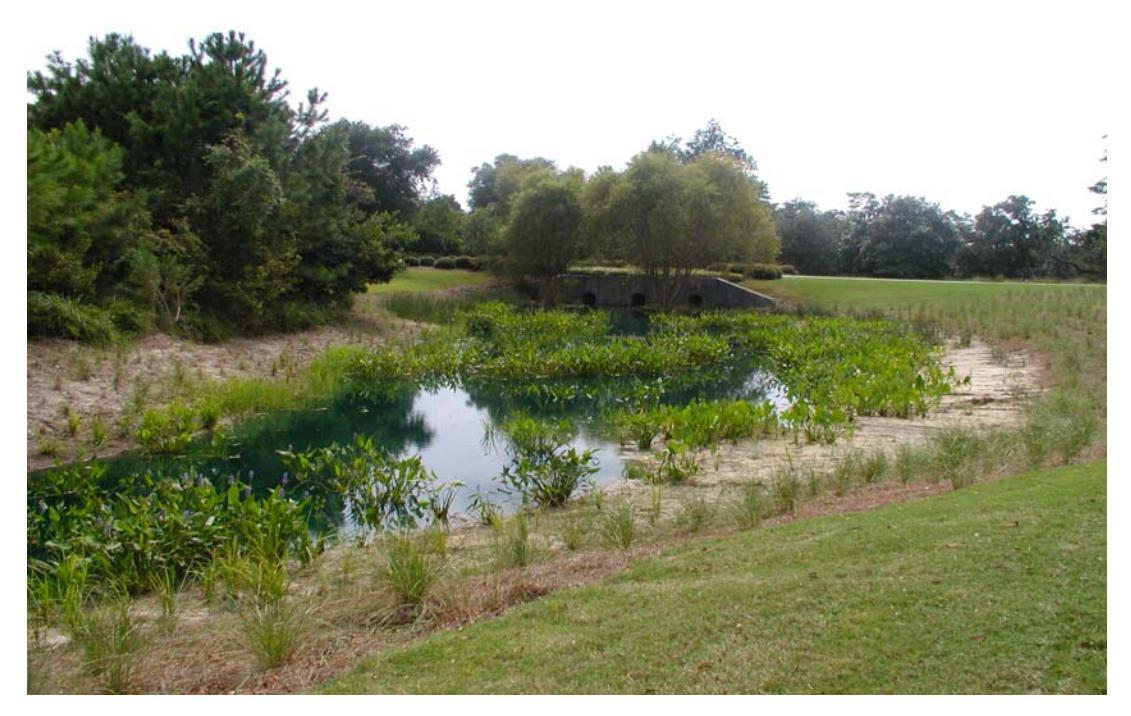
Figure 3. Completed wetland at EPGC in summer 2009.

1. Stormwater wetland - Gate Area

Status: Detailed design and construction complete (June 2009). Detailed information related to design and cost is provided in the next section, while plans and photographs of the BMPs are included in Appendix C.

This area originally served as a drainage outlet for surface runoff and from overflow of the main Par 3 pond. This pond receives a significant amount of pumped pond water from Porters Neck Country Club. This target area originally conveyed runoff through a swale underneath the main gate into EPGC and into Little Creek (Gate Outlet location). This area provided an ideal location to expand this drainage conveyance into a stormwater wetland. It also provided the last opportunity for water flowing from this section of EPGC to be treated before discharge into Little Creek.

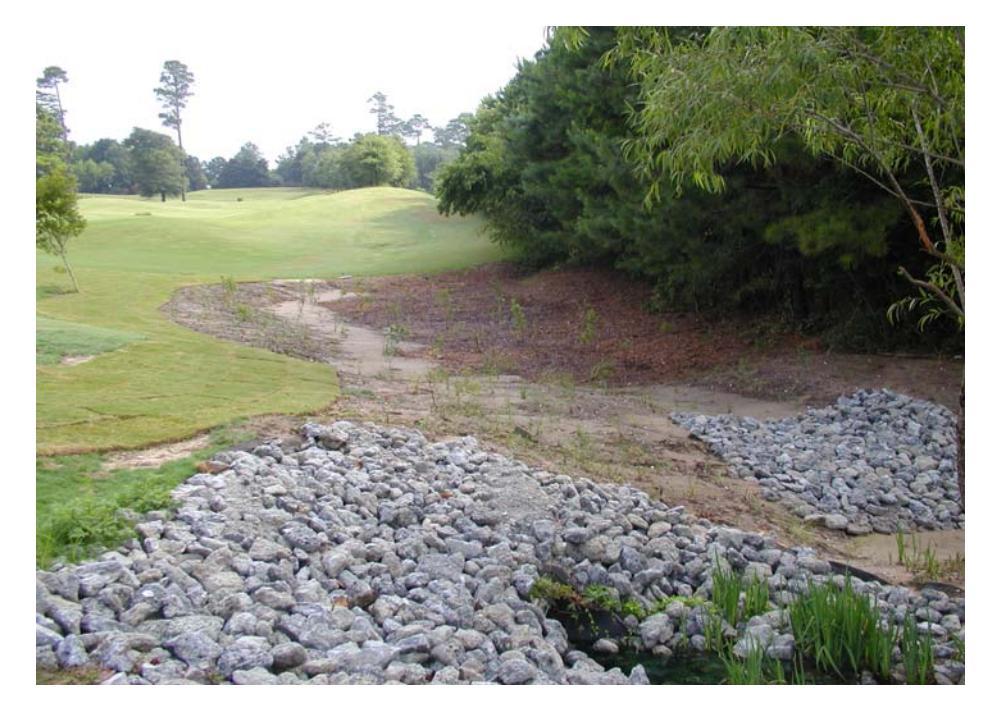
Figure 4. Bioretention area #1 after the initial planting.

2. Bioretention area #1

Status: Detailed design and construction complete (June 2009). Detailed information related to design and cost is provided in the next section, while plans and photographs of the BMPs are included in Appendix C.

The area is located immediately adjacent to the stormwater wetland (BMP #1) and Par 3 pond, receiving surface runoff from the Par 3 course and private houses adjacent to the EPGC. This bioretention area was designed to receive surface runoff from the surrounding area via overland flow or through an 18 inch subsurface stormwater pipe that drains a linear swale on the edge of the property. It could also receive overflow from the stormwater wetland (BMP #1) during very large events. This flow otherwise would directly discharge to the marsh. Since this area would receive flow that is much more intermittent and would frequently be dry, bioretention was the better choice.

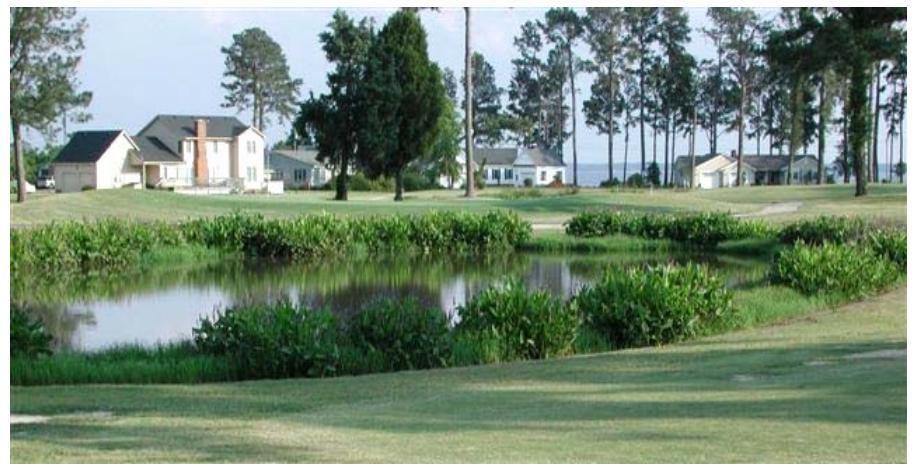
Figure 5. Example of a golf course pond with a vegetated littoral shelf.

The Par 3 Pond receives a significant portion of pumped drainage water from Porters Neck Country Club, and is situated in close proximity to the Gate Outlet to Little Creek. Increasing the storage capacity of the pond by raising the elevation of the pond outlet, while planting the inundated banks with wetland vegetation (i.e. creating a littoral shelf), will increase the potential of this pond to function more like a combined stormwater wet pond and stormwater wetland complex. Due to its shape, this pond has a large perimeter that provides a large area for a littoral shelf.

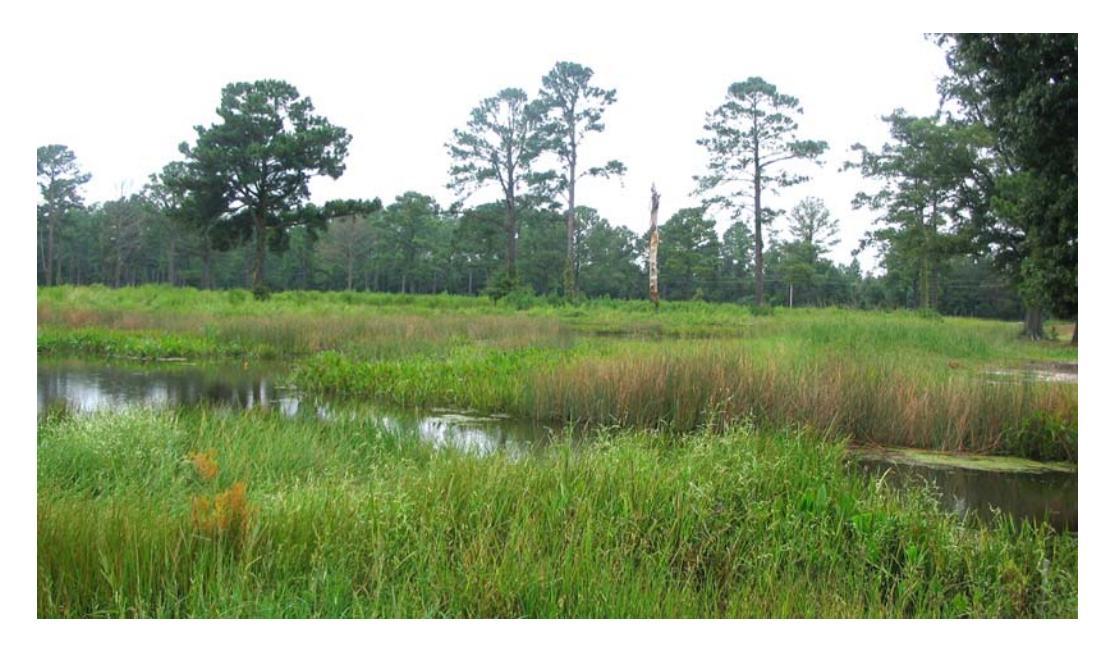
Figure 6. Example stream and wetland complex on a golf course in eastern NC.

Our recommendation to increase the assimilative capacity of the hole #4 pond is to daylight the discharge pipe flowing across #3 fairway and convert that area into a linear stormwater wetland. The removal of a stormwater pipe and installation of a stream and wetland system will dramatically improve the capacity of this area to react to peak storm flows. The expansion is targeted for an existing valley, and would require minimal earthwork and impact to the course. Other areas surrounding the pond that could be considered for this wetland are at elevations that would require extensive excavation that would otherwise make this BMP cost prohibitive for this area.

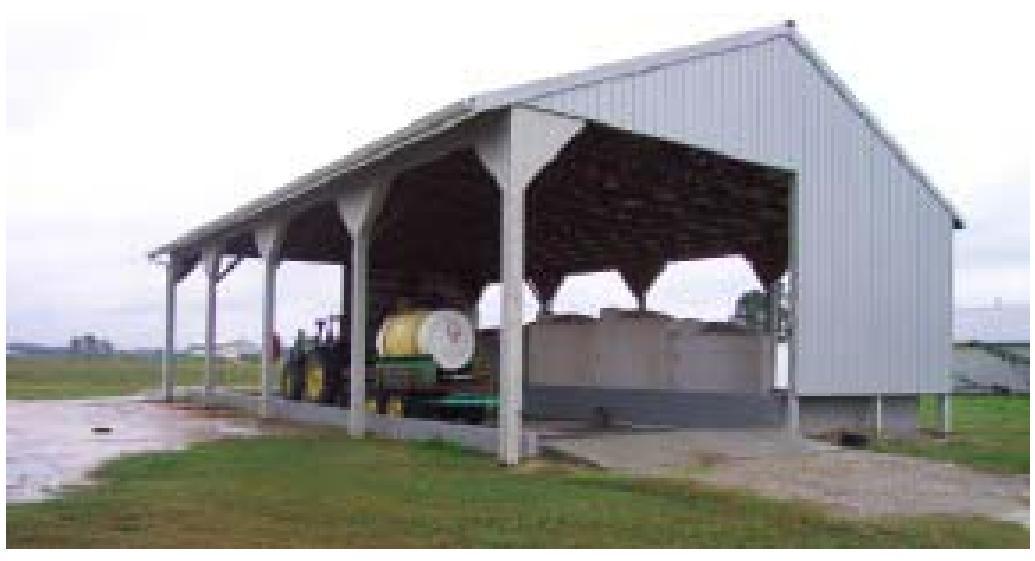
Figure 7. A storage shed would keep materials dry, contained and accessible.

The EPGC maintenance shop is the storage area for many vehicles, golf course equipment, and materials. The EPGC has implemented many measures to control runoff from vehicle washing and chemical storage areas, and they utilize materials recycling. Nutrient and waste (i.e. grass clippings) management by the EPGC maintenance personnel is exemplary, as evidenced by the low nutrient and sediment concentrations measured in water exported from the facility. This management could be improved by implementing some structural and non-structural BMPs around the maintenance facility. Improvements for further reducing sediment and other solids from entering the stormwater system could be realized by 1) storing sand and mulch on a covered containment pad and 2) applying mulch to landscaped bermed areas around the facility. Other recommendations to be considered include pervious parking, the regular sweeping or removal of materials and debris from impervious surfaces, and installation of cisterns or other runoff reduction strategies.

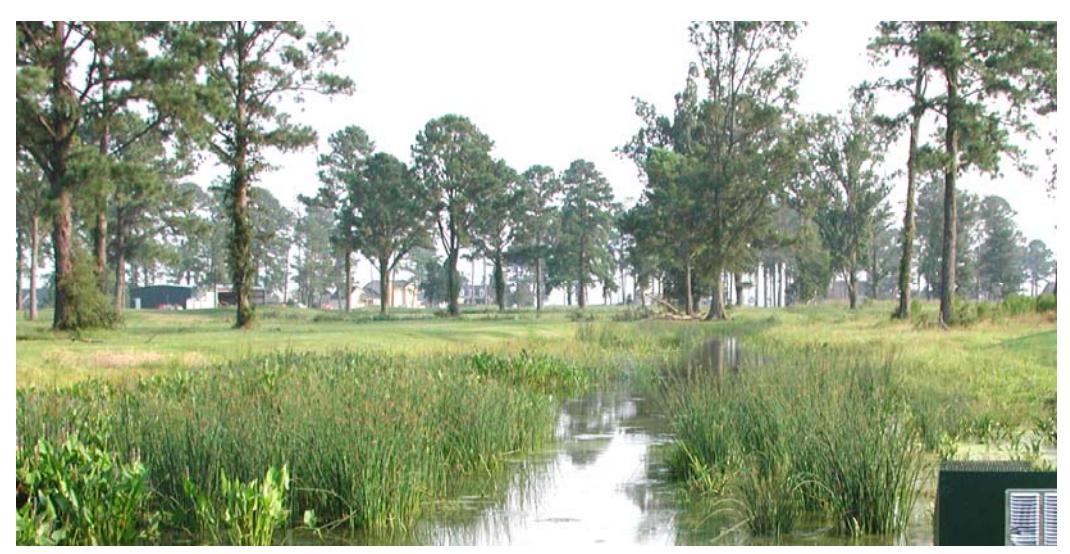
Figure 8. A golf course stream with adjoining wetlands. Edenton, NC.

The recirculating stream constructed on EPGC provides increased retention time of water on-site, while providing two man-made stream segments that meander through the course as a water hazard. It is also a visual amenity that adds to the course's attributes. In several locations, this stream and floodplain do not seem to be as stable as intended, particularly along hole #17 of the course. Other locations along the stream corridor also appear to be ideal locations to position small floodplain wetlands to trap runoff entering the stream from the fairways and during higher than normal flow events. The area could provide excellent treatment and would benefit from stabilization efforts and implementation of grade control structures that would improve storage and treatment.

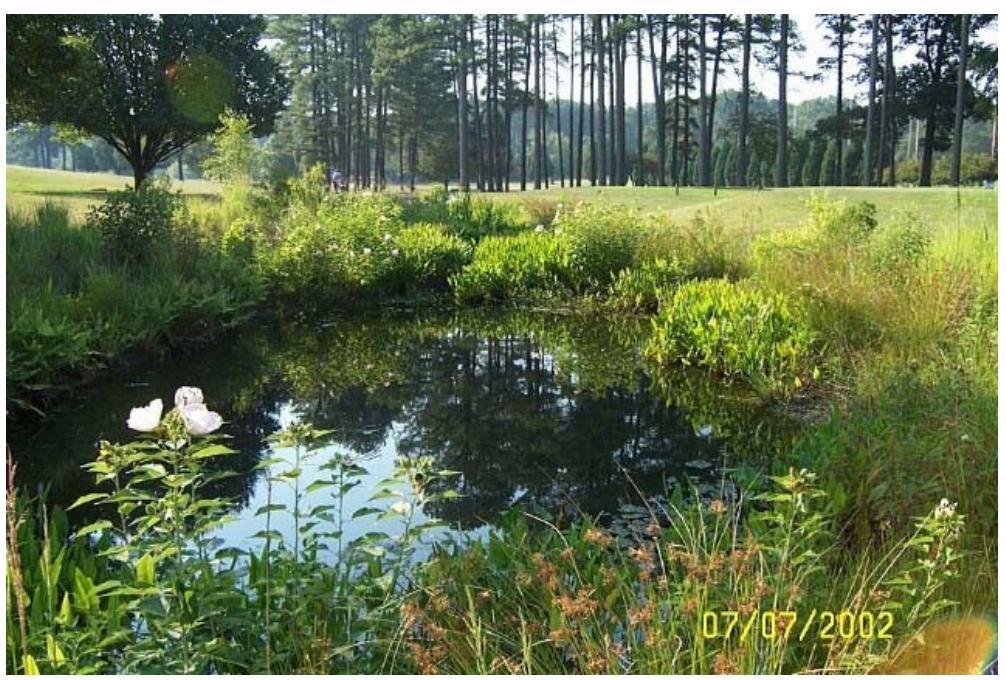
Figure 9. Another golf course pond with vegetated littoral shelf. Durham, NC.

EPGC has at least 10 ponds around the golf course. All of the ponds were designed with a flow-through outlet. The latest stormwater pond designs incorporate a storage feature and a drawdown pipe which allows storm flows to be held and released over a period of several days. Many of the outlet devices on the course could be retrofitted to provide this type of storage. Plantings could be added that would improve treatment potential and biological activity in the ponds. In addition, a common course management method involves adding black colored dye to the ponds to reduce algal blooms. It is our opinion that this practice should be eliminated to enhance natural natural mechanisms for bacteria removal.

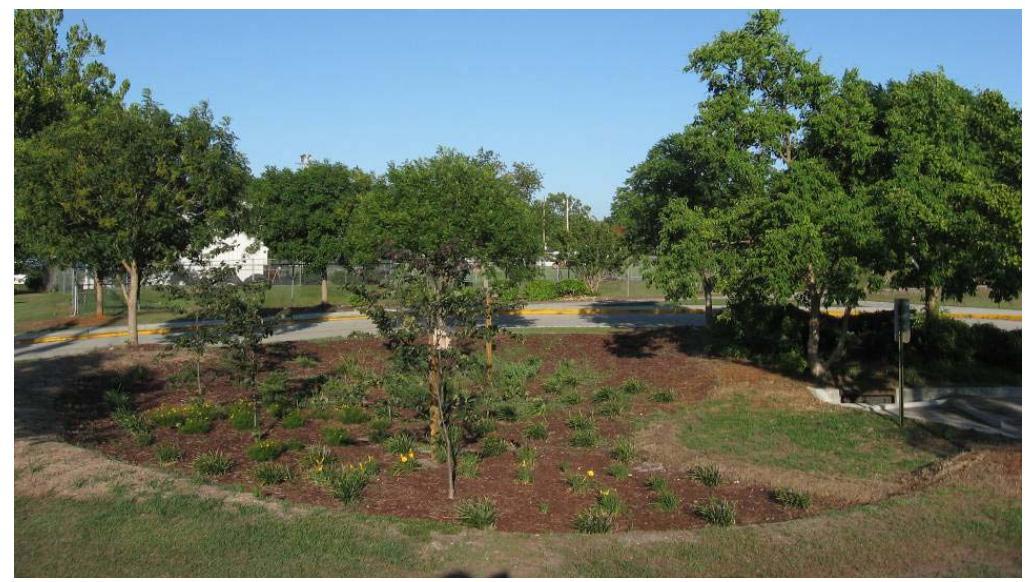
Figure 10. A typical bioretention area can look like a garden or be planted with grasses.

The club and pro-shop facility comprise a significant percentage of the very small amount of impervious surface on the EPGC facility. There are several opportunities for EPGC to reduce its runoff impact around this area. Cisterns to collect runoff from roof top areas to be used in landscape irrigation, rain gardens located in low areas now receiving runoff from parking areas and concrete pads, and water collection systems to collect excess washwater generated from washing golf carts and cars that could be become reuse water.

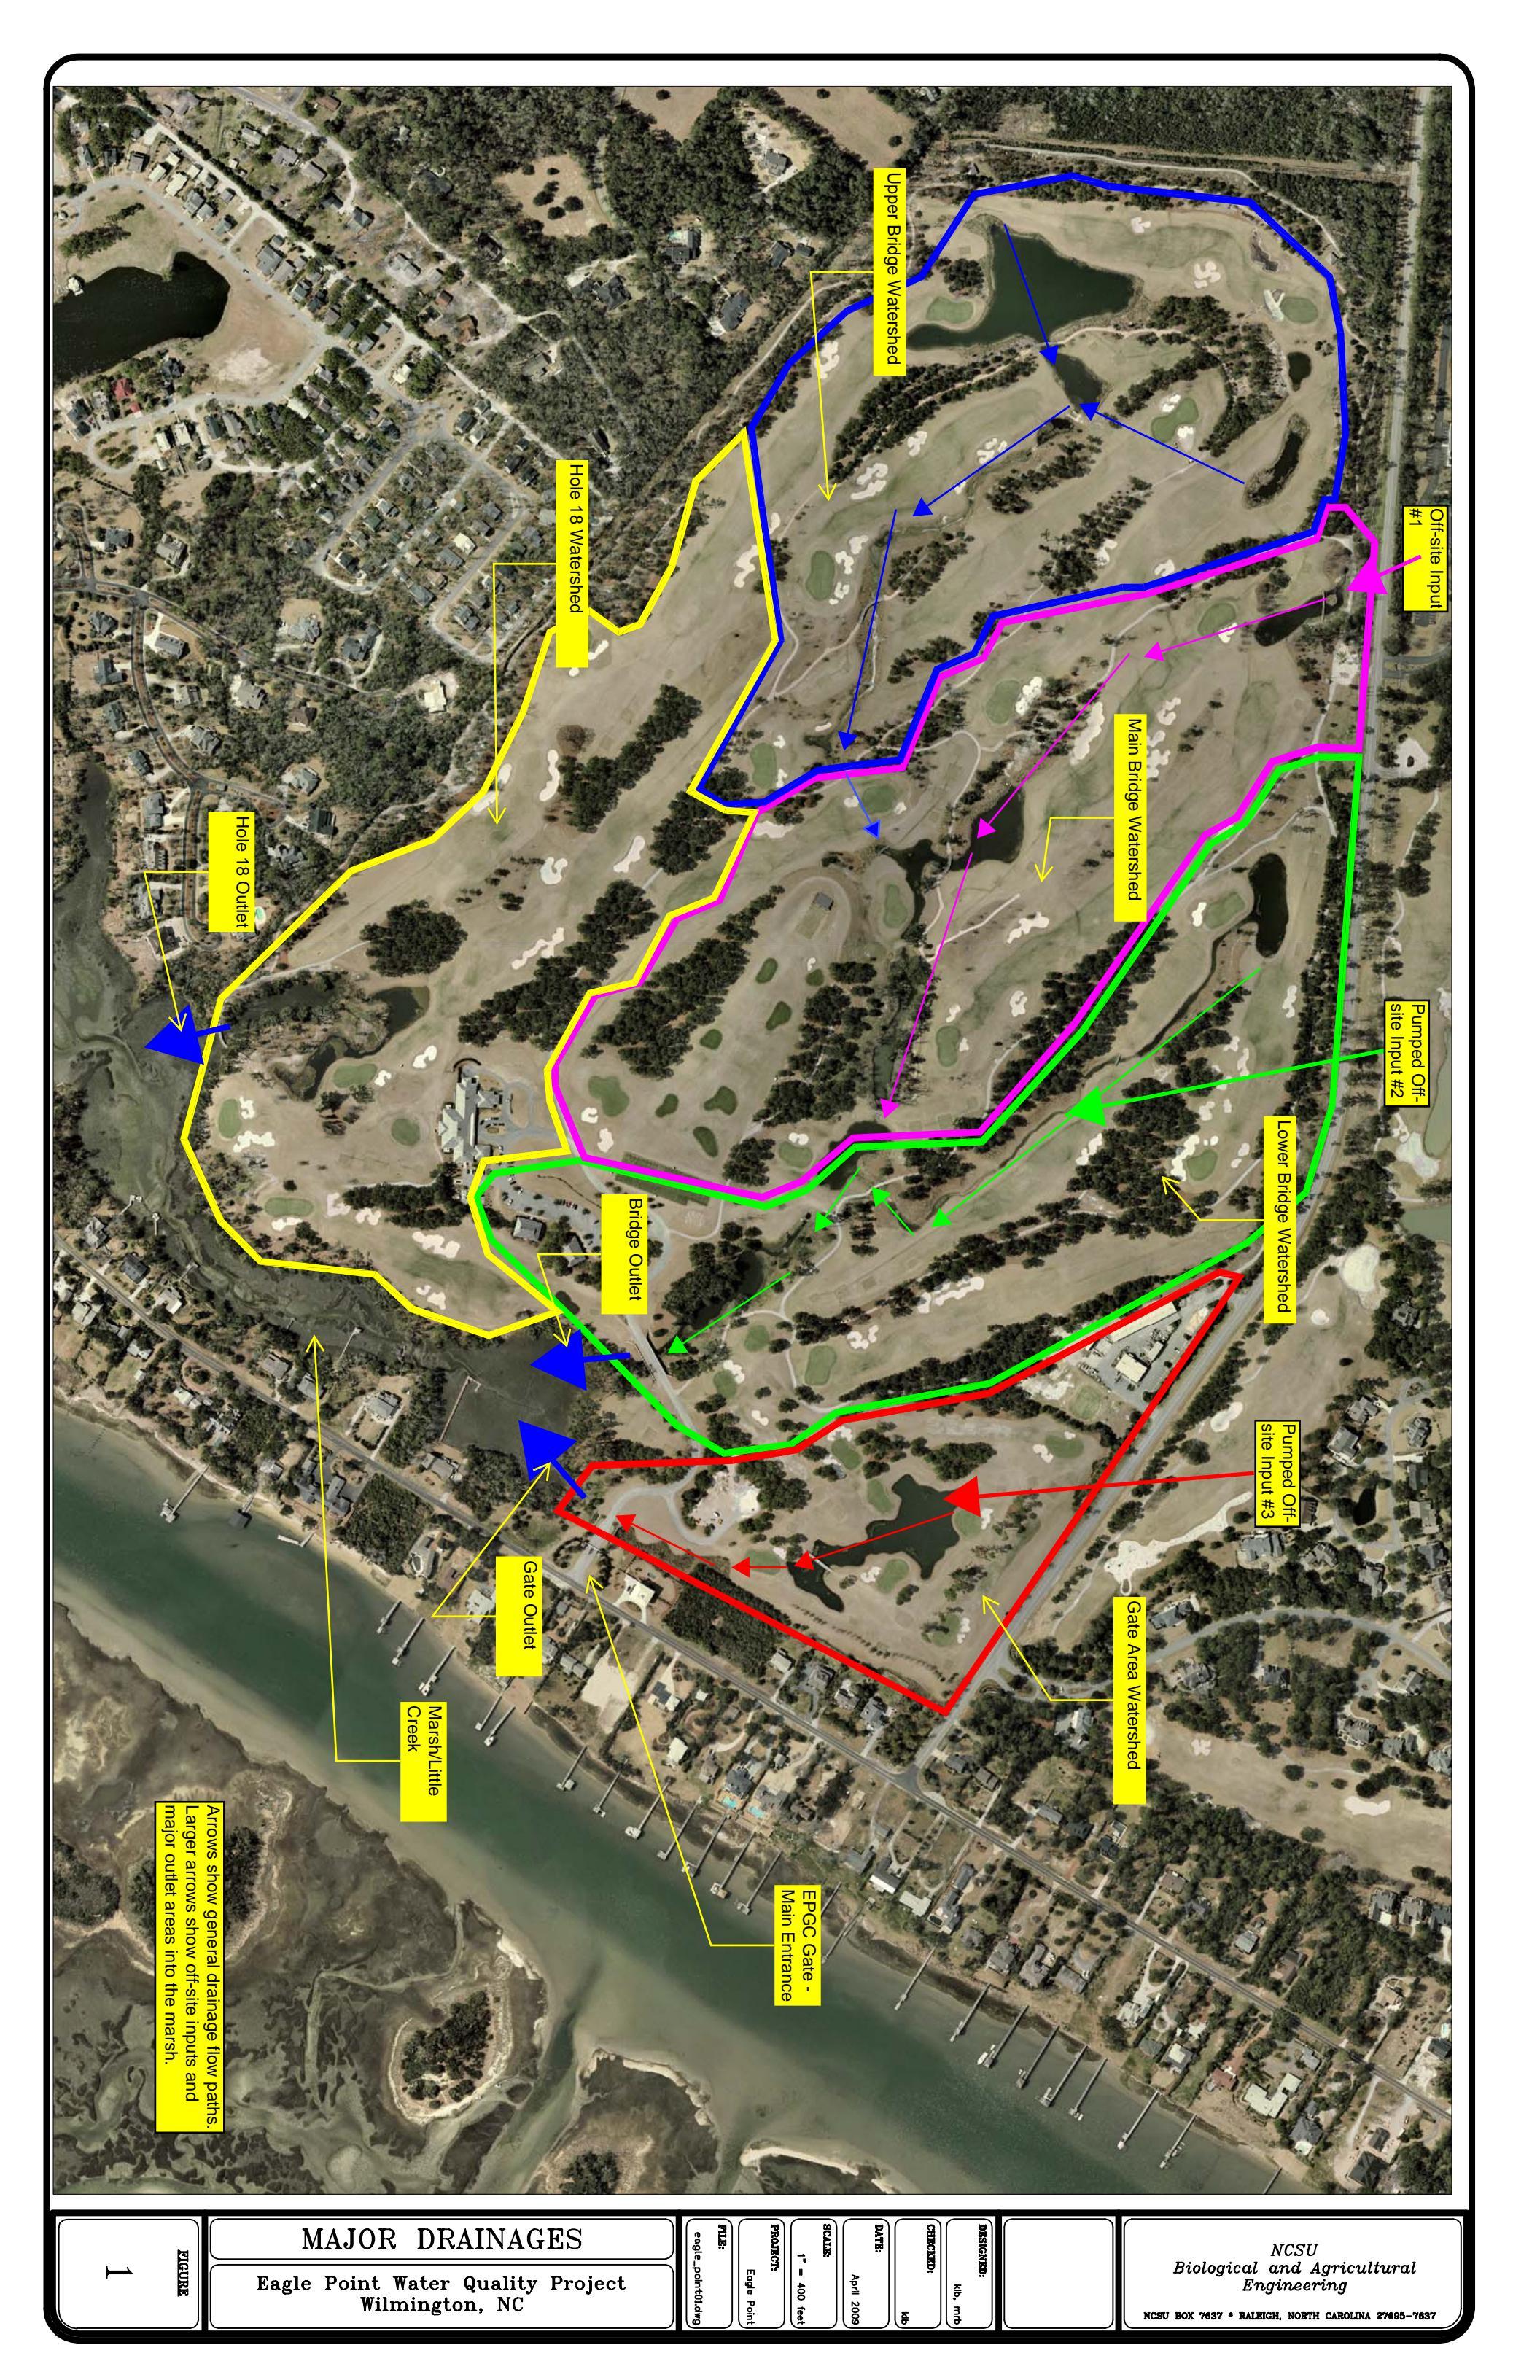
Figure A1 (located in Appendix A) shows the main drainage flows into and out of the EPGC. This map has been included as an individual sheet and can be printed to scale on a tabloid sized sheet of paper. Outlined areas have been delineated as subwatersheds within EPGC based on topography and surface conveyances. Small arrows illustrate general flow paths for each area and how they connect. The course has been broken up into 5 major drainage areas, which combine to flow through 3 major outlets into Little Creek. The main outlets are shown with large blue arrows, and each corresponds with a sampling location in the monitoring portion of the project. The largest combined watershed flows to the area labeled Bridge Outlet. Three drainages, making up the largest portion of the course, combine to generate the outflow in this area. This includes the Upper, Lower, and Main Bridge Watersheds. The drainage area flowing to the Gate Outlet appears to deliver the second most flow into the marsh. The primary EPGC areas flowing to the outlet include the maintenance shop and the par 3 course. The Hole 18 Outlet delivers the least amount of stormwater into Little Creek. This drainage consistes of only a few golf holes, but also includes the EPGC clubhouse area.

The course receives off-site stormwater inflow from 3 main areas. These inputs include pond outflow from the Plantation Village Retirement Community (Off-site Input #1), and pumped flow from the Porters Neck Country Club (Pumped Off-site Inputs #2 and #3. Stormwater flow from the buildings and parking lots in the retirement community collects in a centralized pond that flows under Porters Neck Road (large purple arrow). During larger rainfall events, this water overtops Porters Neck Road as it flows towards EPGC. Additional flow is pumped from the Porters Neck Country Club through subsurface pipes to two locations on EPGC; a force main that enters a stream (large green arrow) and into the large pond located on the Par 3 course (large red arrow). Porters Neck Country Club uses a blue dye in their ponds that was observed in the stream and par 3 pond at EPGC on several occasions.

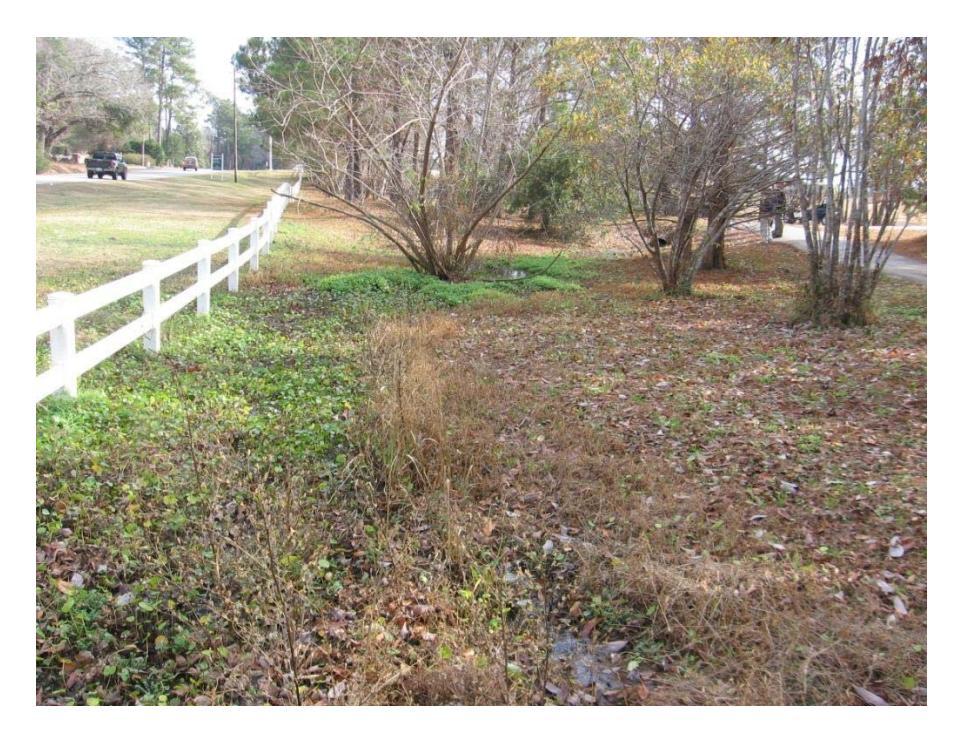
Figure B1. Stormwater enters EPGC from Plantation Village Retirement Community through and 18 in pipe during normal flow or across Porters Neck Road (left) during high flow events.

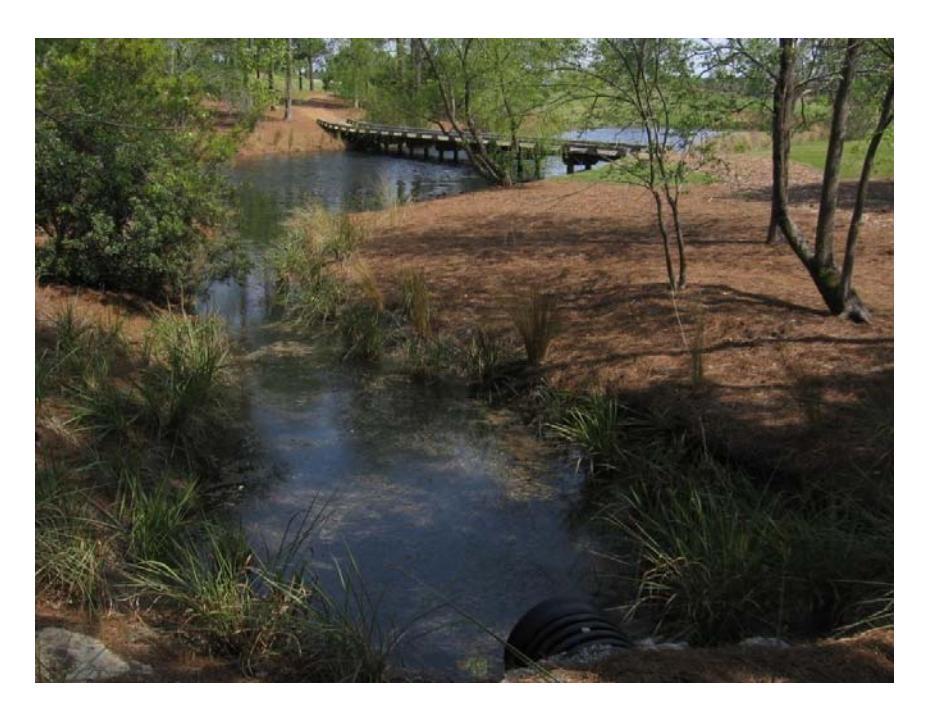
Figure B2. Pond near Hole #4 tee box that receives runoff from Plantation Village Retirement Community

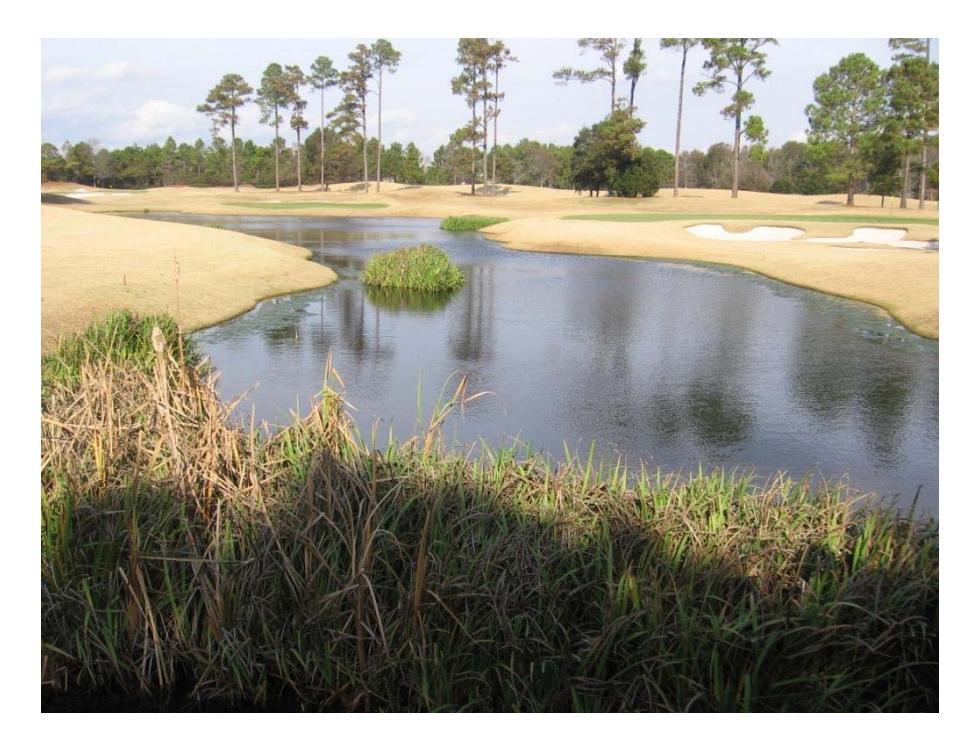
Figure B3. Par 3 pond that receives pumped stormwater from Porters Neck County Club

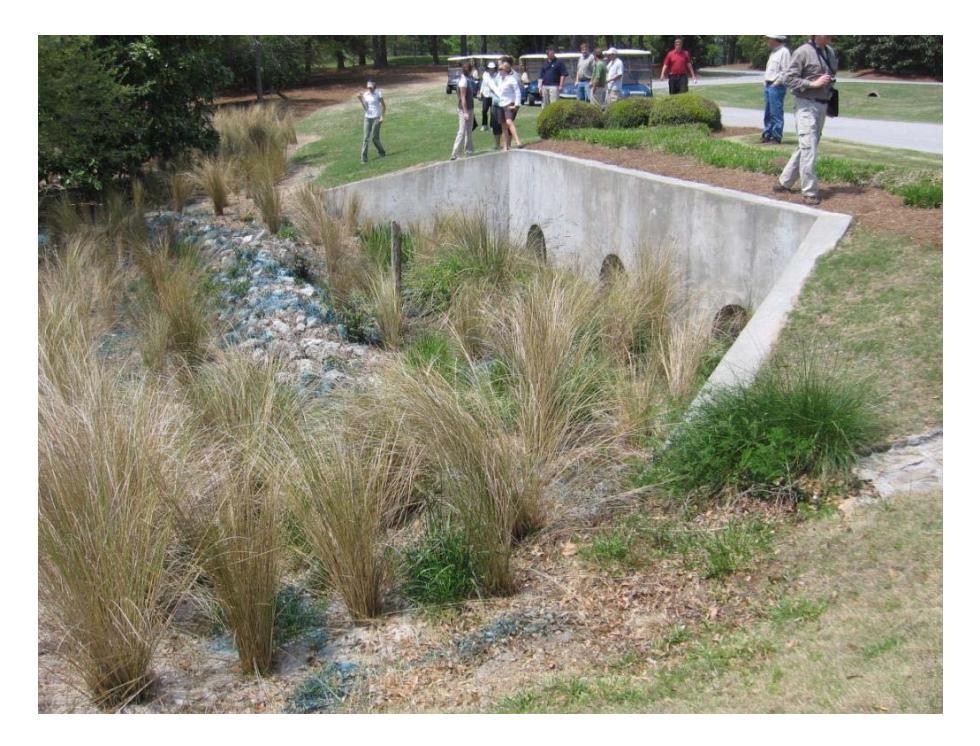
Figure B4. Gate Outlet to Little Creek and marsh area

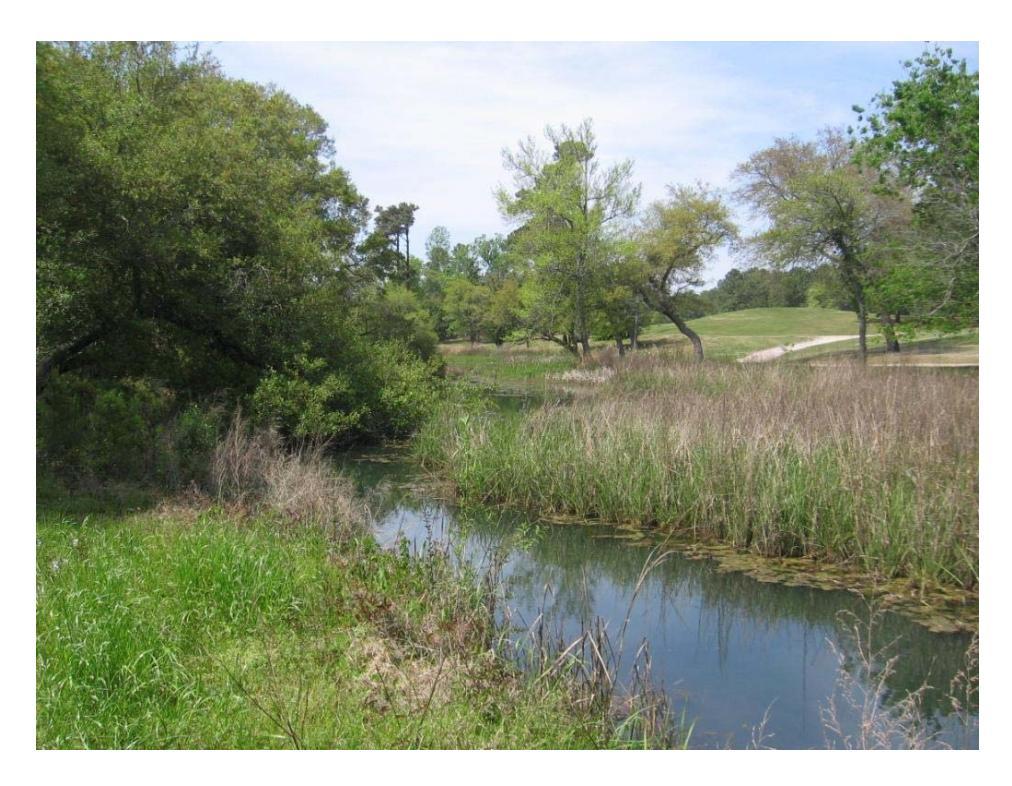
Figure B5. Little Creek within EPGC, upstream of the Bridge Outlet

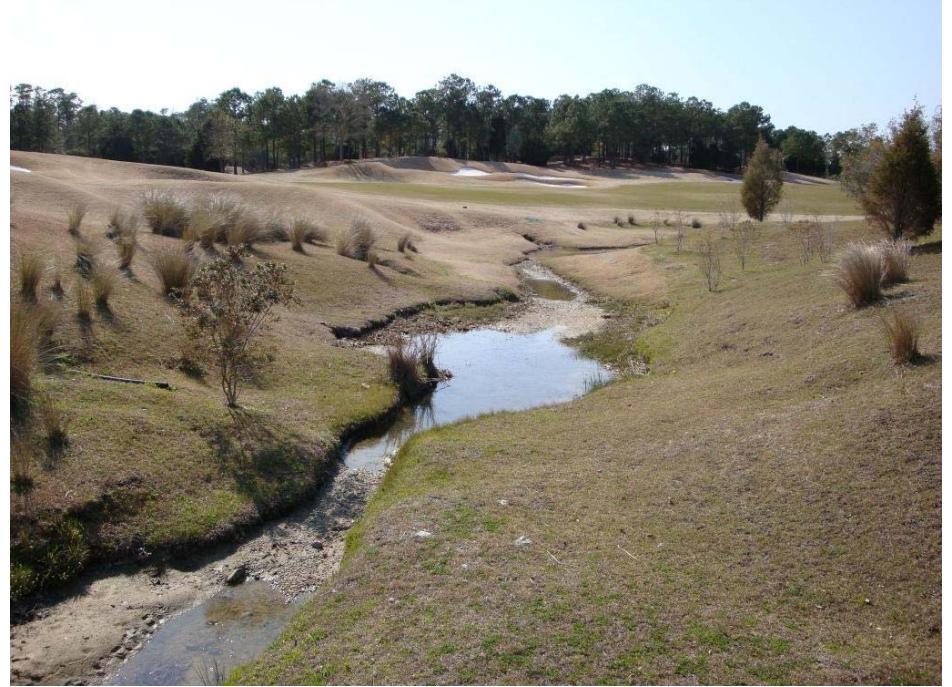
Figure B6. Area for stream stabilization and floodplain wetlands near hole #17

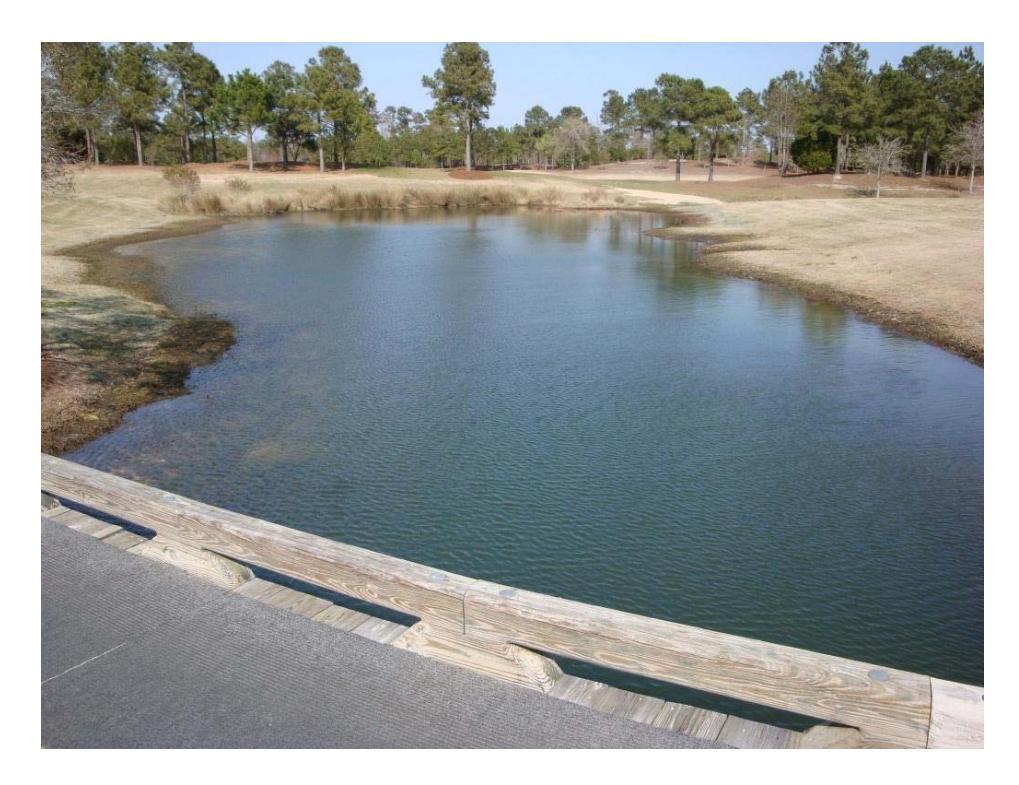
Figure B7. An ideal pond for adding storage and a littoral shelf

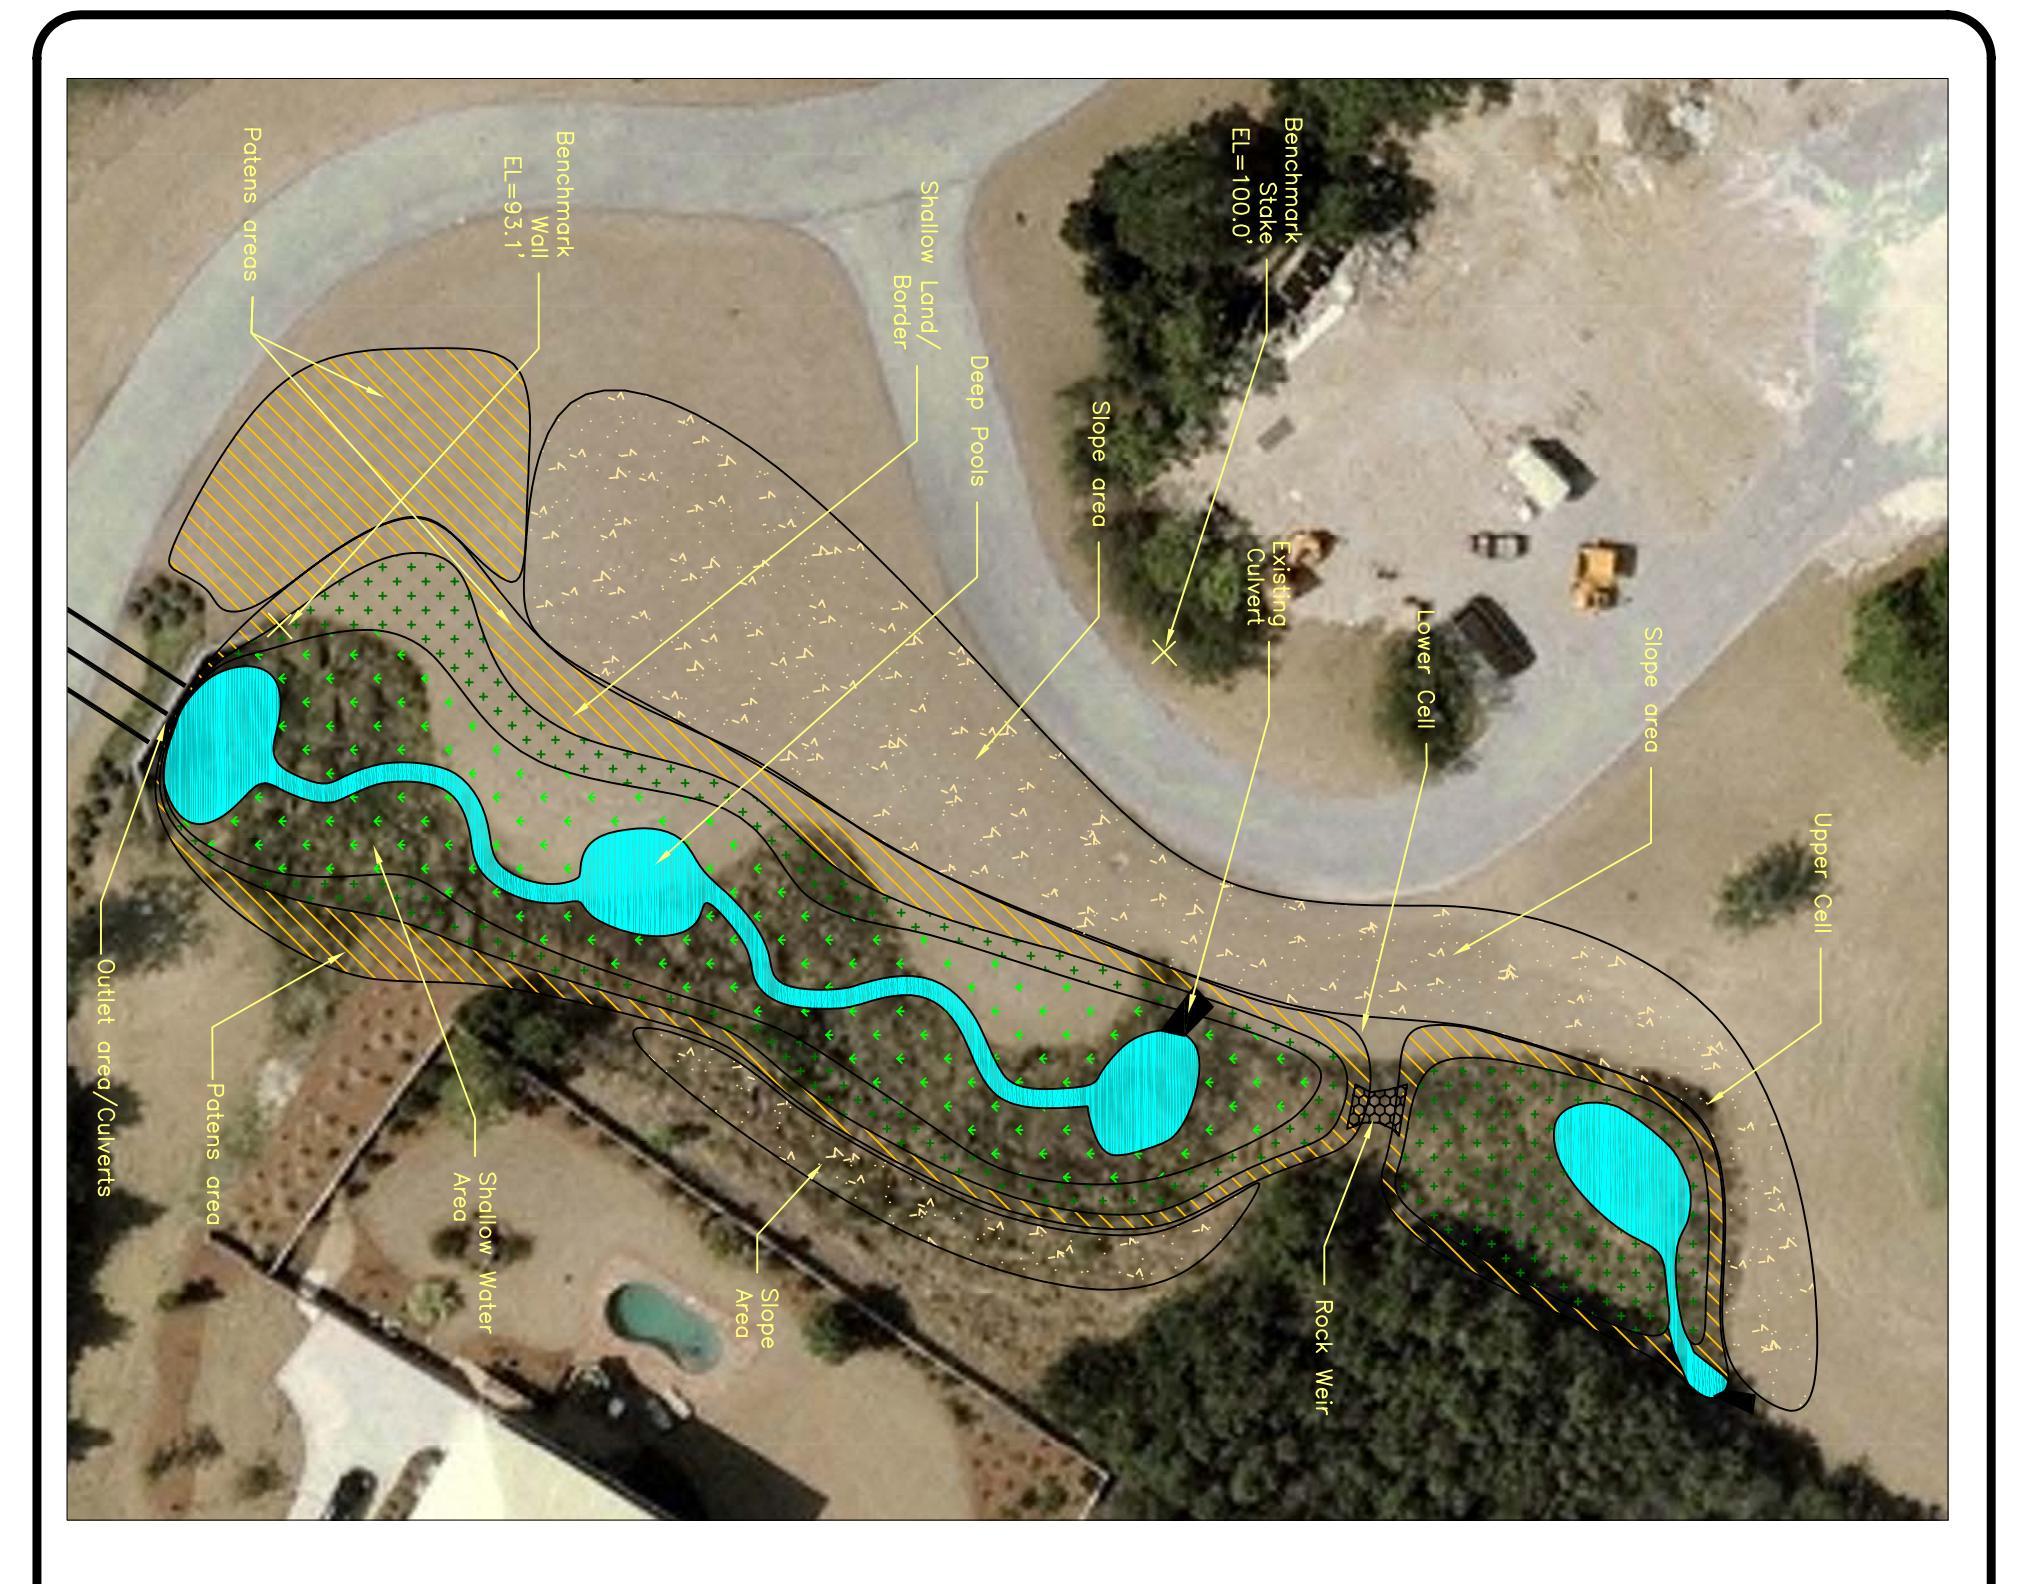
PROJECT NARRATIVE: This is a joint project between Eagle Point Golf Course, New Hanover County, North Carolina Coastal Federation, the Community Conservation Assistance Program, and the NC Clean Water Management Trust Fund. The purpose of this project is to build a stormwater treatment system that will intercept golf course runoff before it outlets into the Little Creek marsh. Construction of the wetland will involve bulk grading in shallow excavations, detailed grading of wetland features and berms, with particular attention to erosion control and re-seeding/planting. The project will also involve the installation of some outlet control.
