FINAL REPORT

Stormwater BMPs and LID measures to protect coastal waters near Eagle Point Golf Club

Submitted to: New Hanover County Planning Department

Submitted by: NCSU Biological and Agricultural Engineering Department

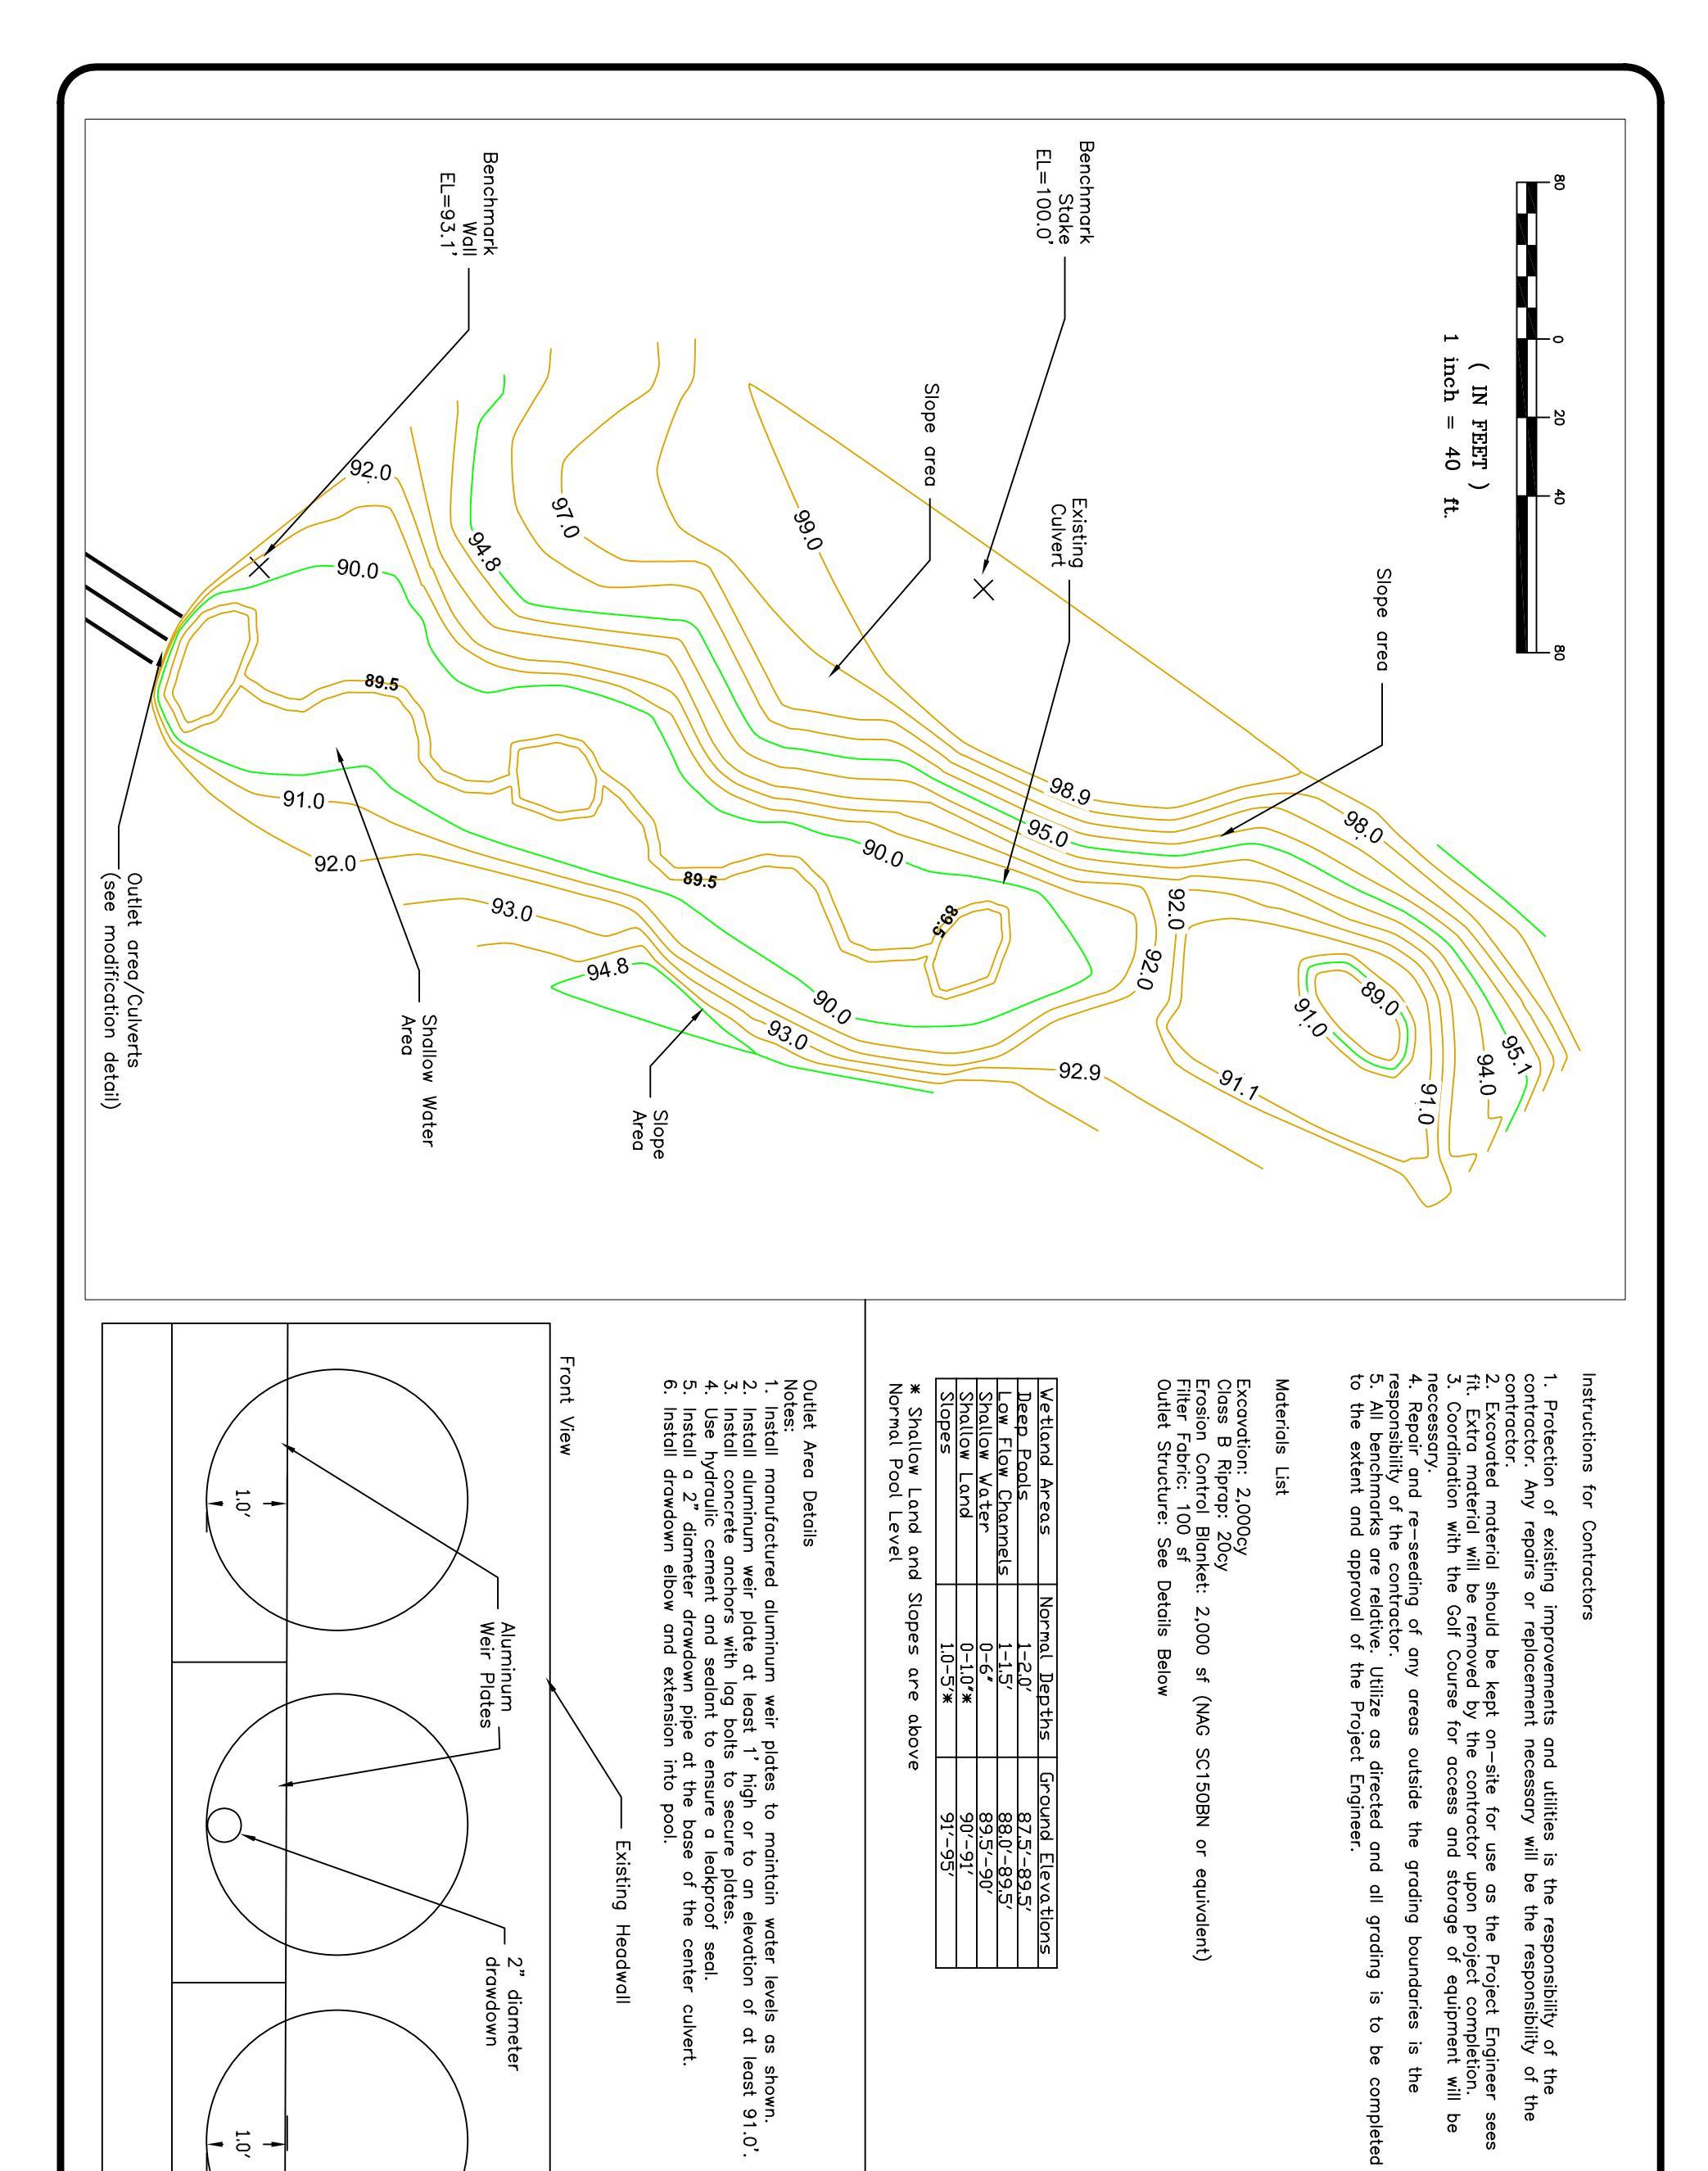
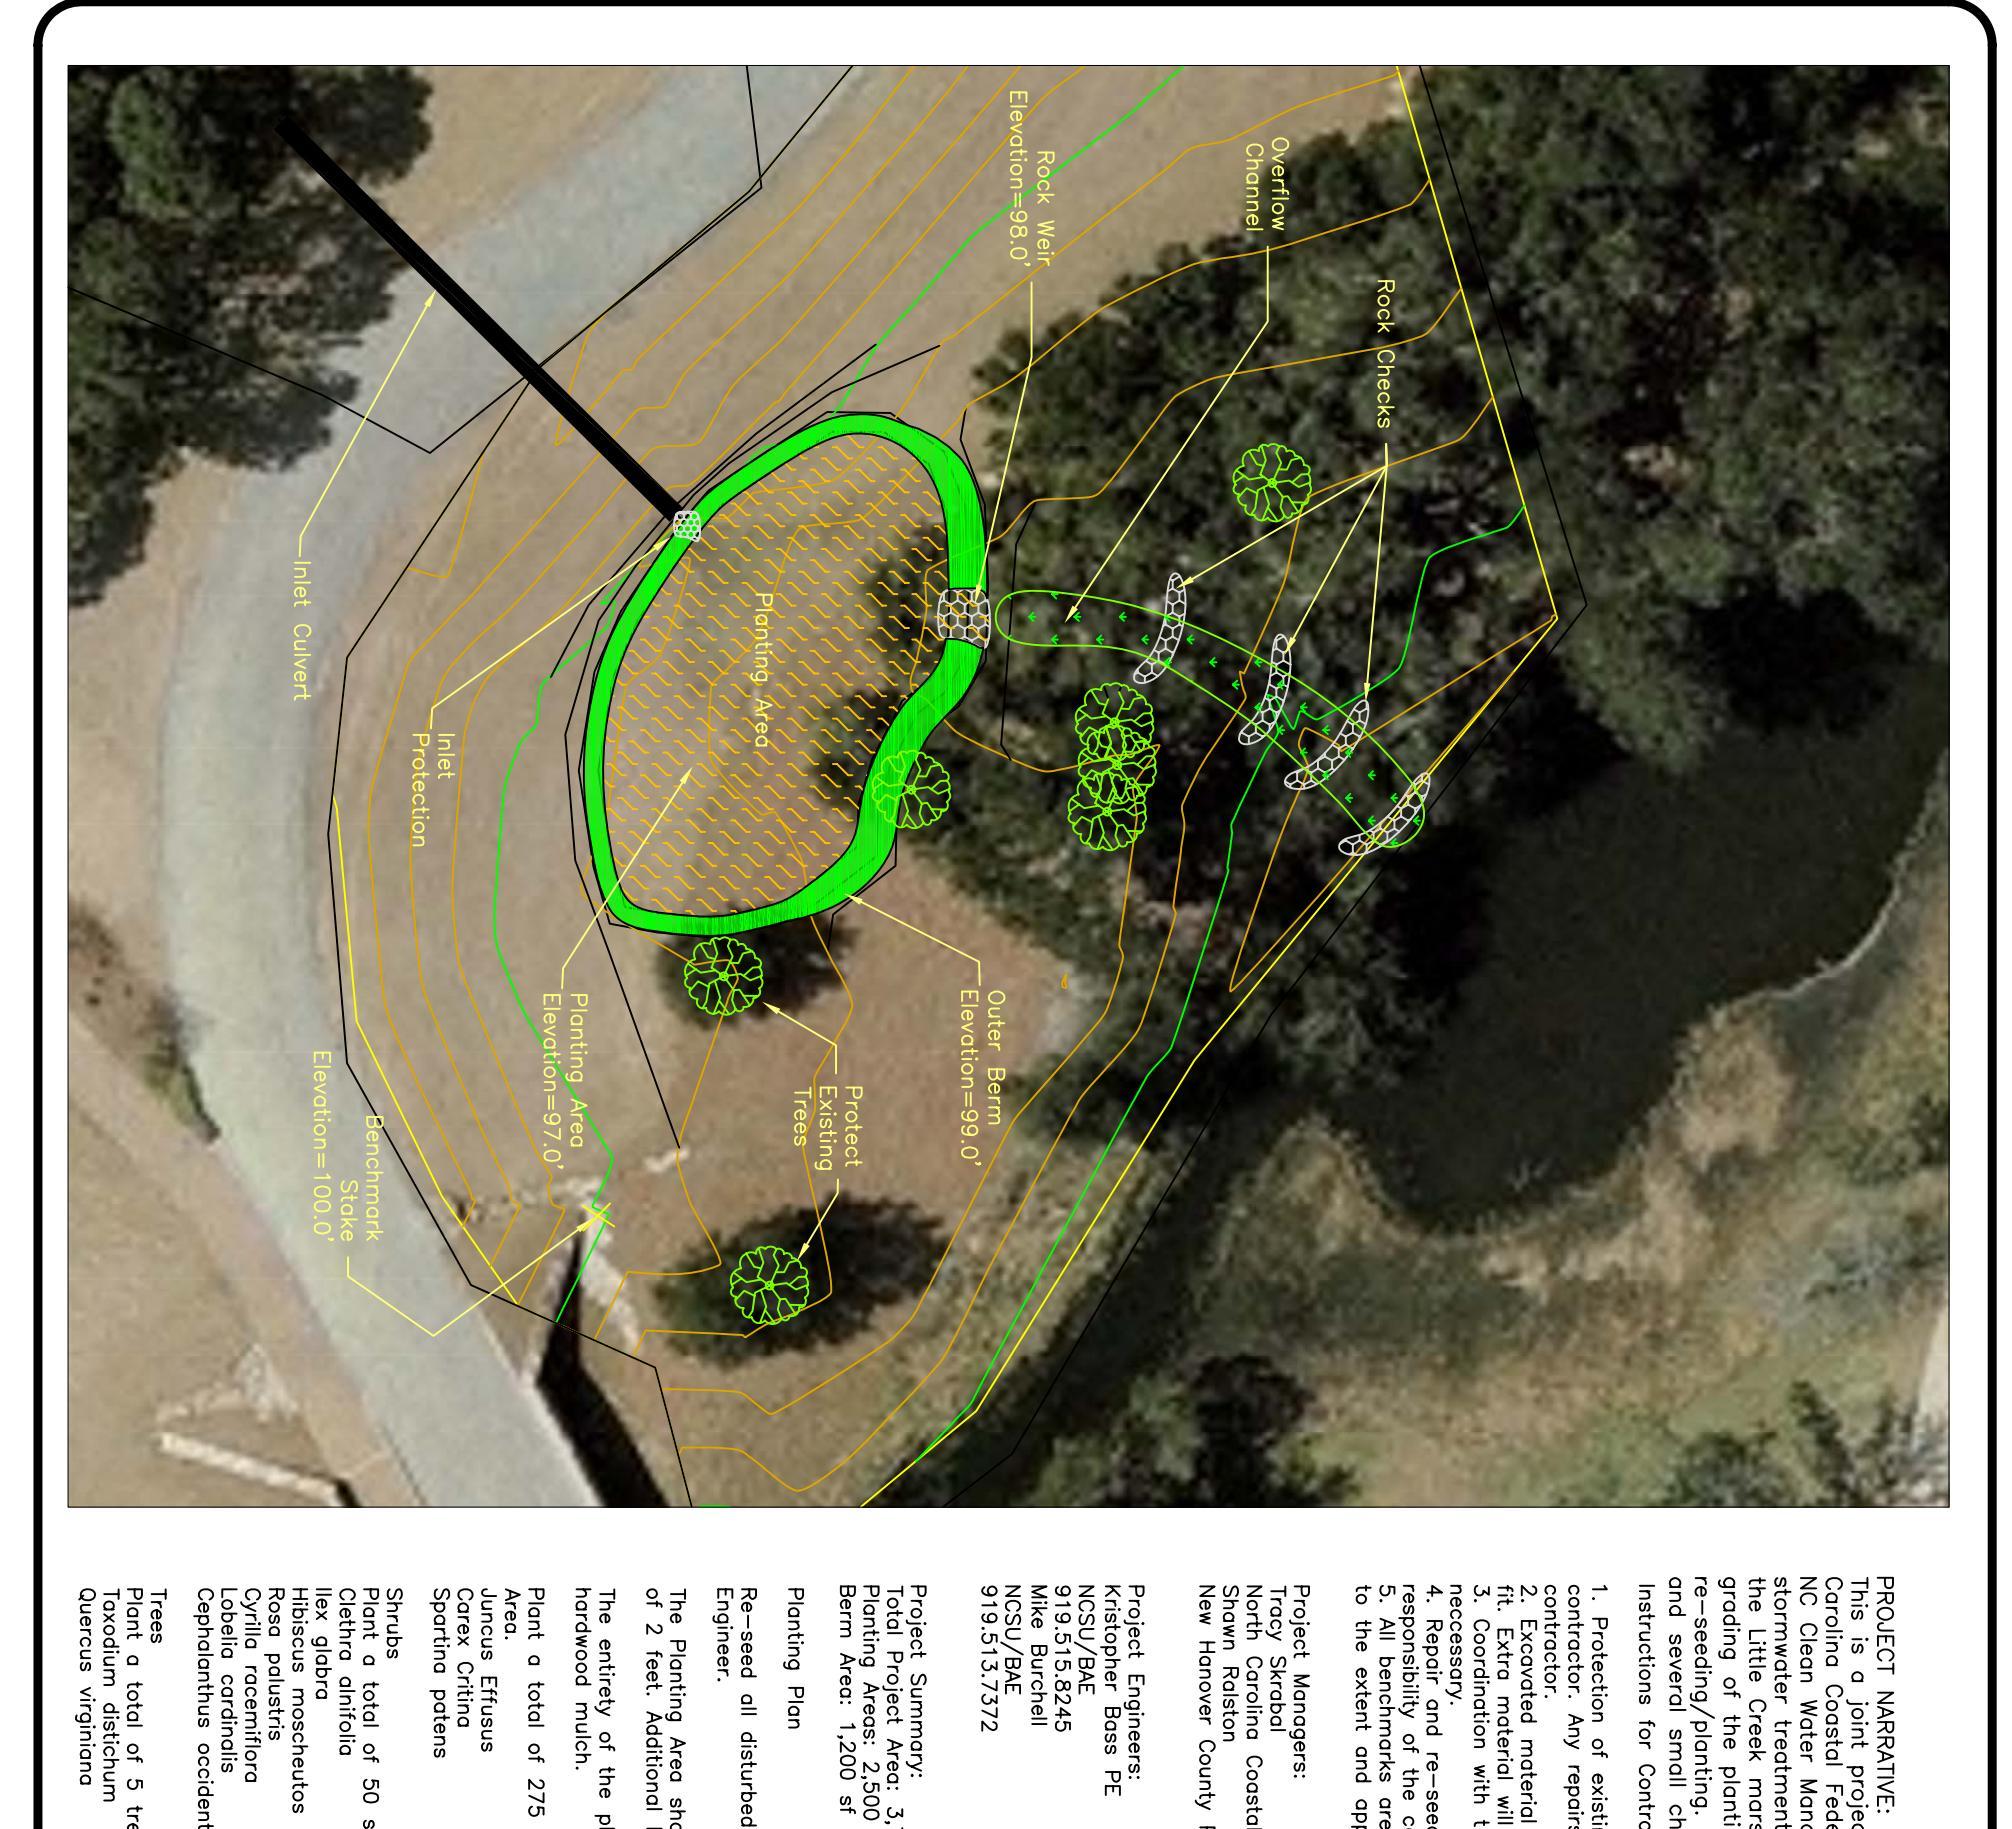
PROJECT NARRATIVE: This is a joint project between Eagle Point Golf Course, New H Carolina Coastal Federation, the Community Conservation Assistc NC Clean Water Management Trust Fund. The purpose of this p stormwater treatment system that will intercept golf course run the Little Creek marsh. Construction of the bioretention area wi grading of the planting area and berms, with particular attentio re-seeding/planting. The project will also involve the installation and several small check dams. Instructions for Contractors

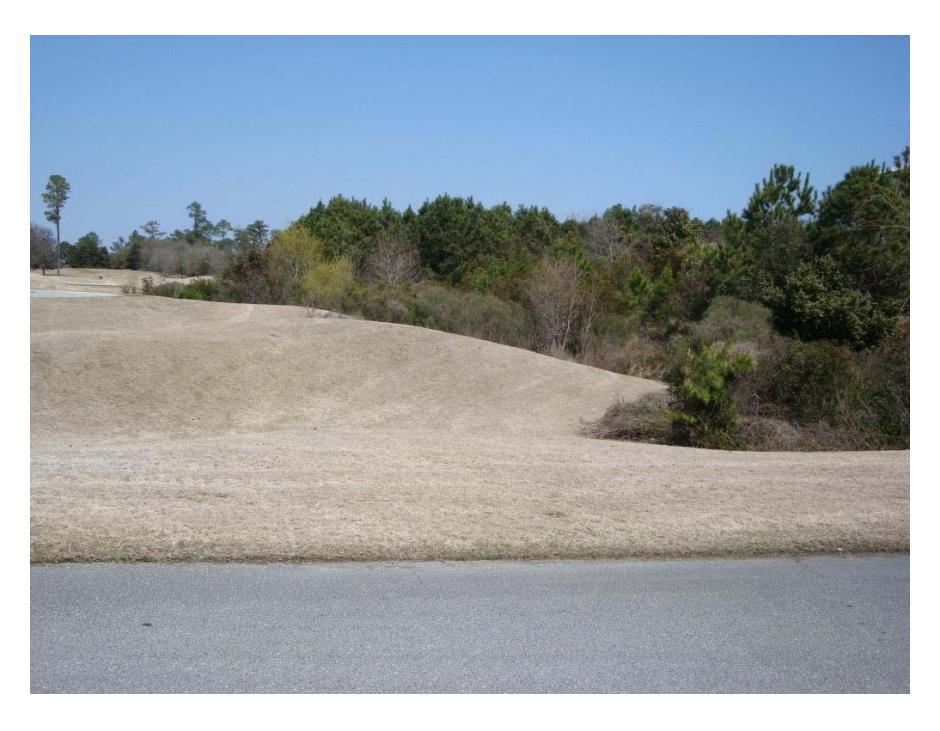
Figure C1. Stormwater wetland area prior to construction

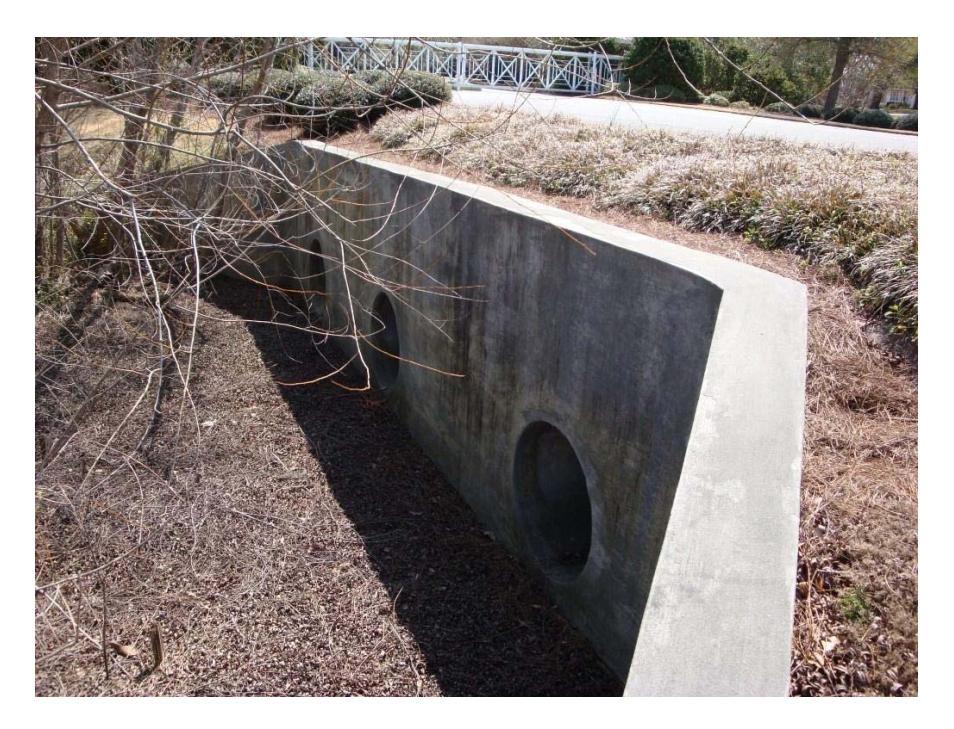
Figure C2. Stormwater wetland outlet area prior to construction (discharges to Little Creek through Gate Outlet location)

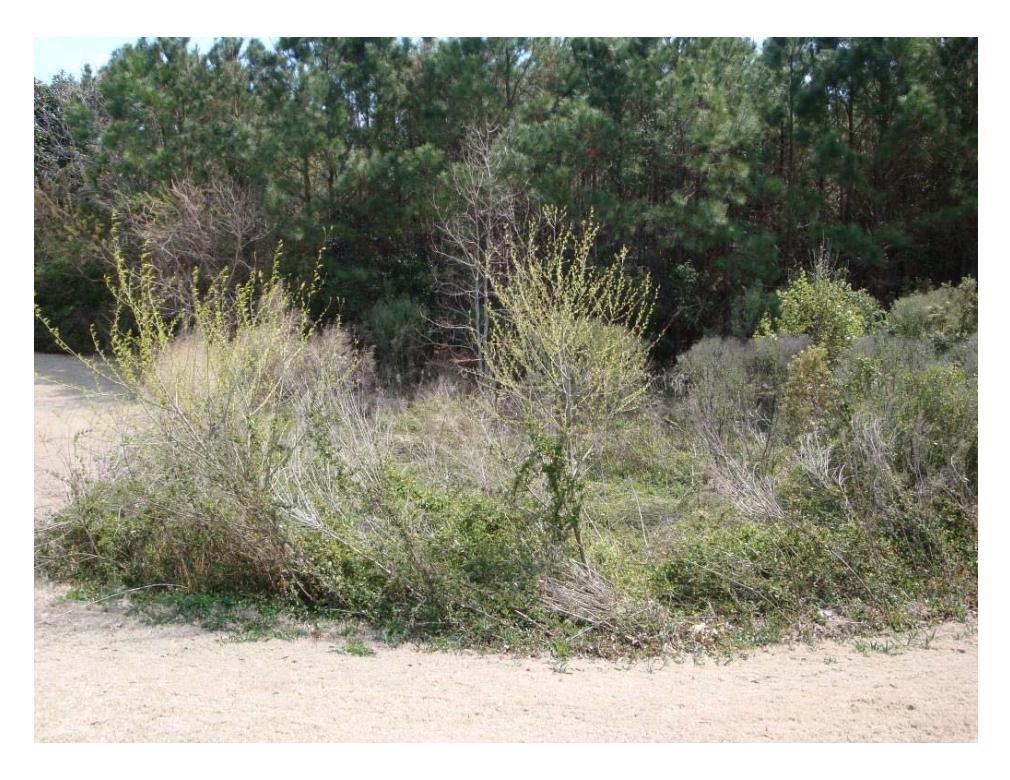
Figure C3. Bioretention area #1 prior to construction

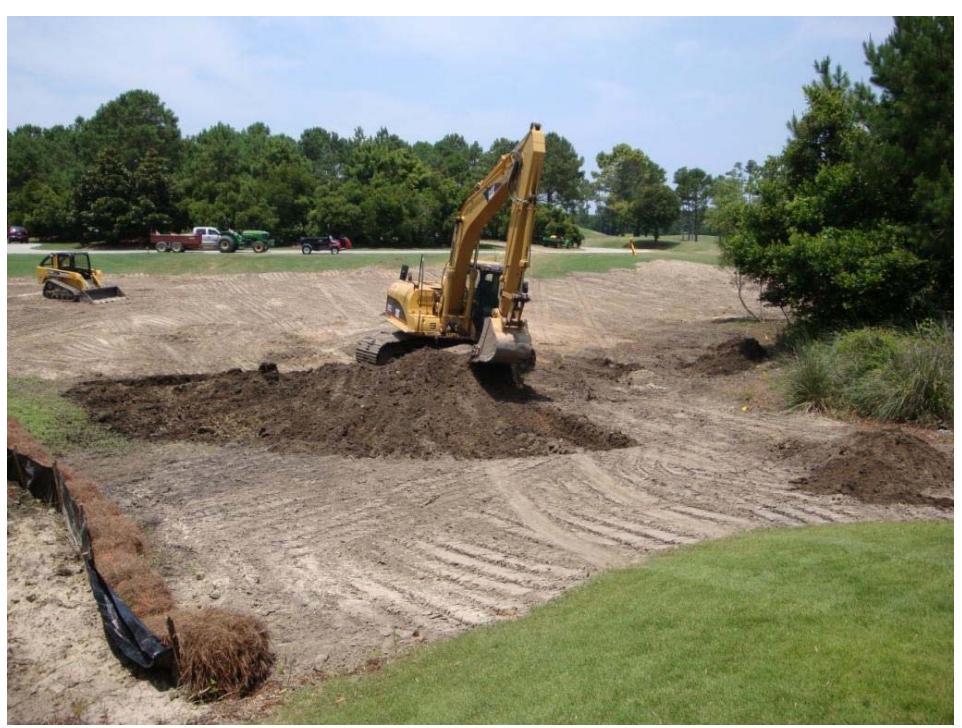
Figure C4. Excavation of the stormwater wetland. Topsoil was stockpiled and redistributed to enhance wetland plant growth

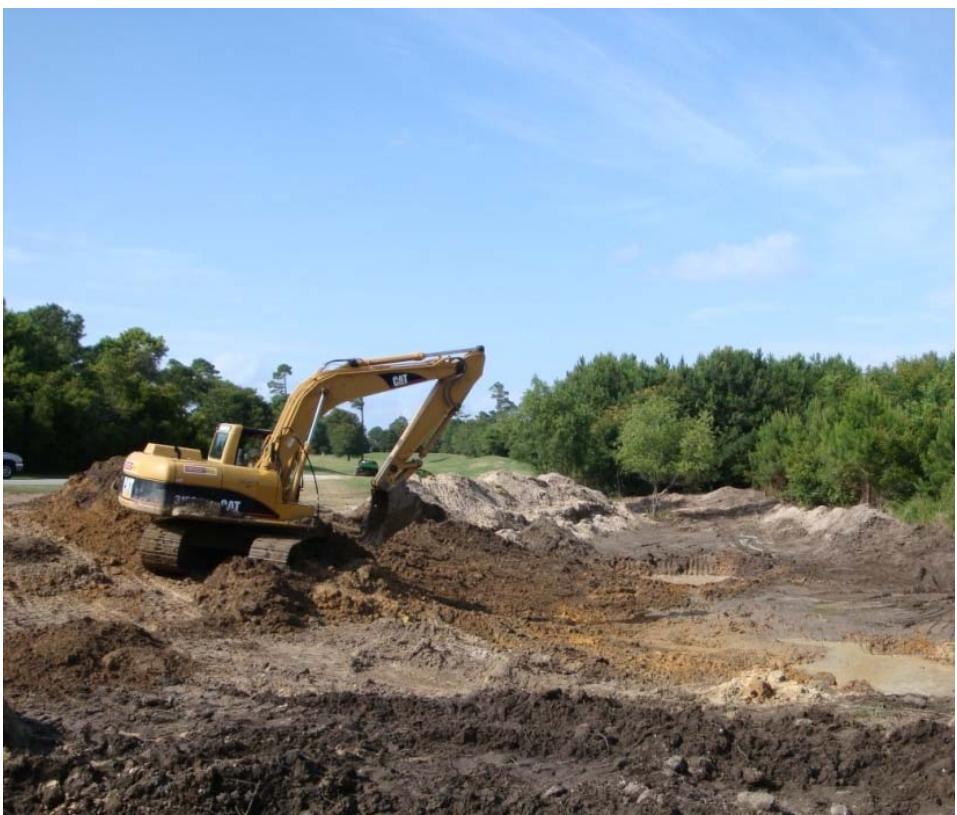
Figure C5. Excavation of the deep pools in the stormwater wetland.

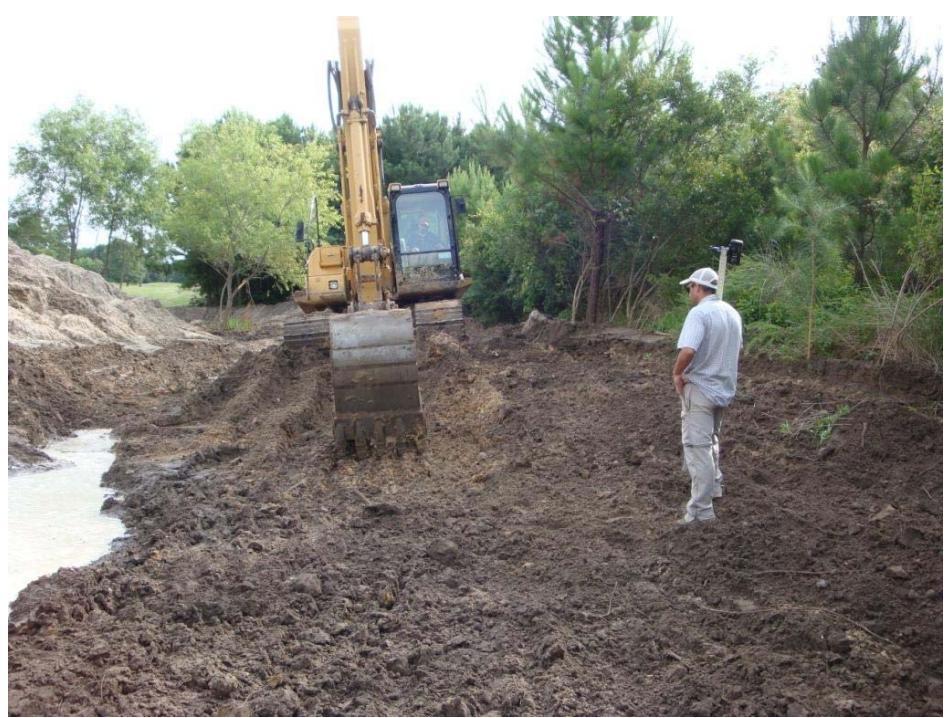
Figure C6. Construction oversight ensured designed elevations were achieved and soil was not overly compacted during excavation to enhance planting

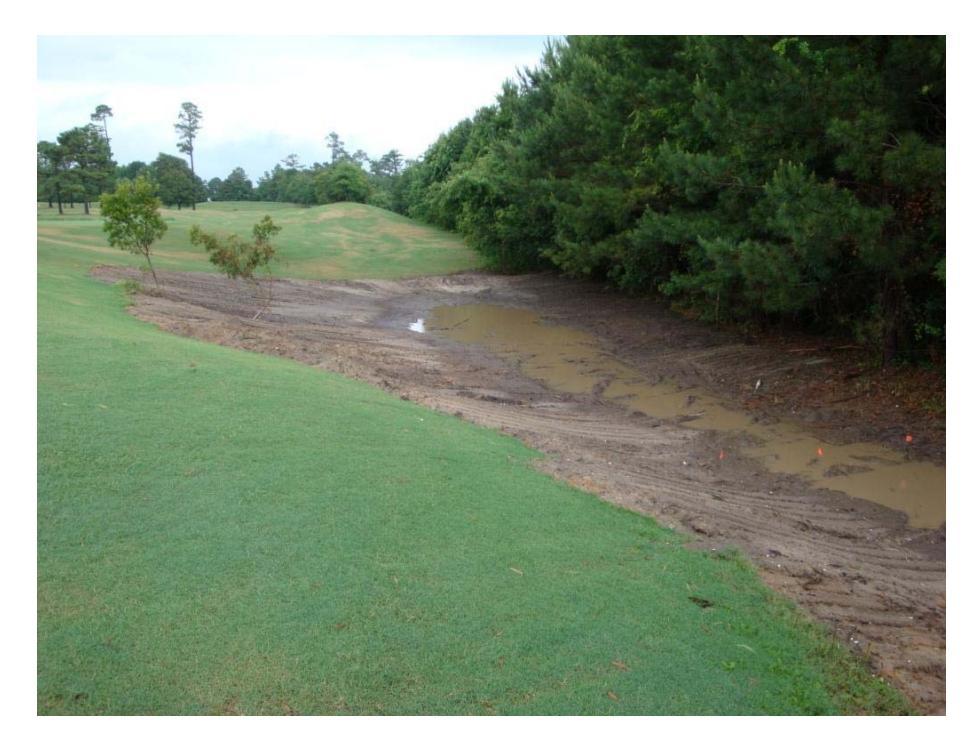
Figure C7. Bioretention area #1 capturing runoff prior to planting

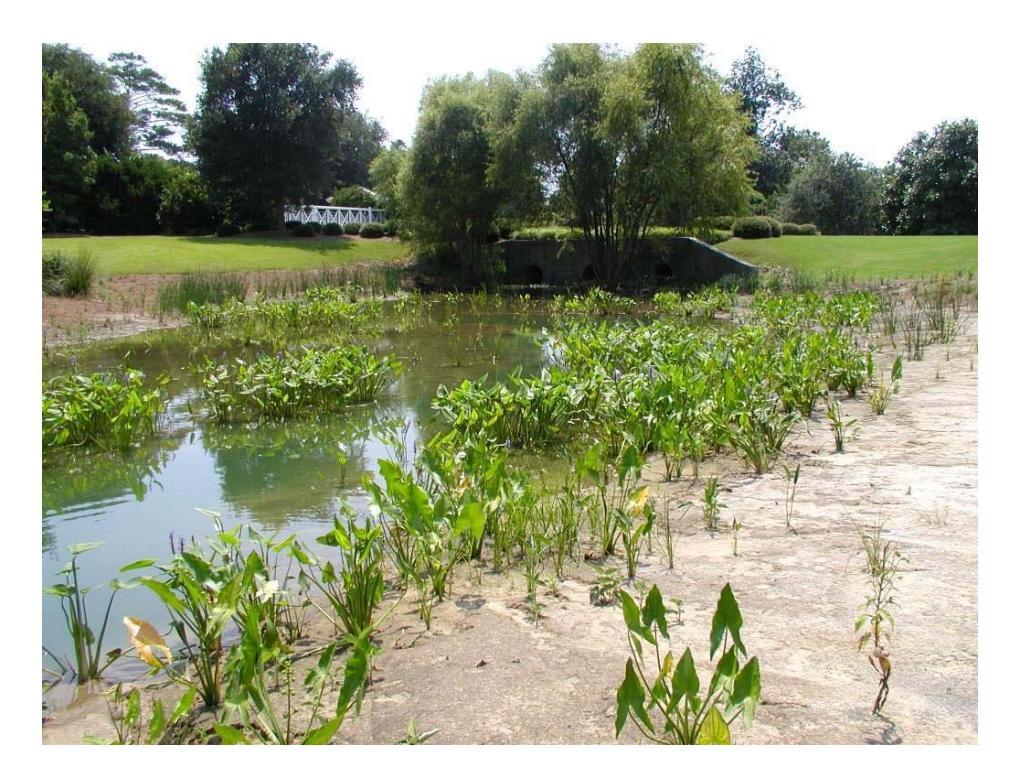
Figure C8. Stormwater wetland 2 months after planting (August 2009)

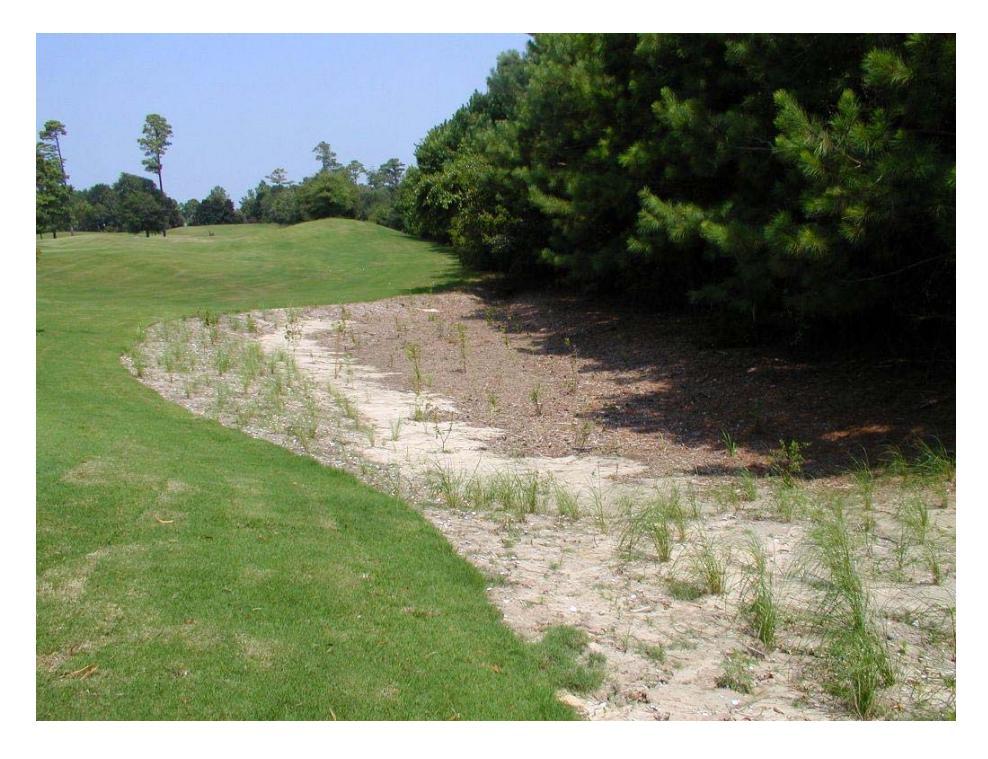
Figure C9. Bioretention area 2 months after planting (August 2009)

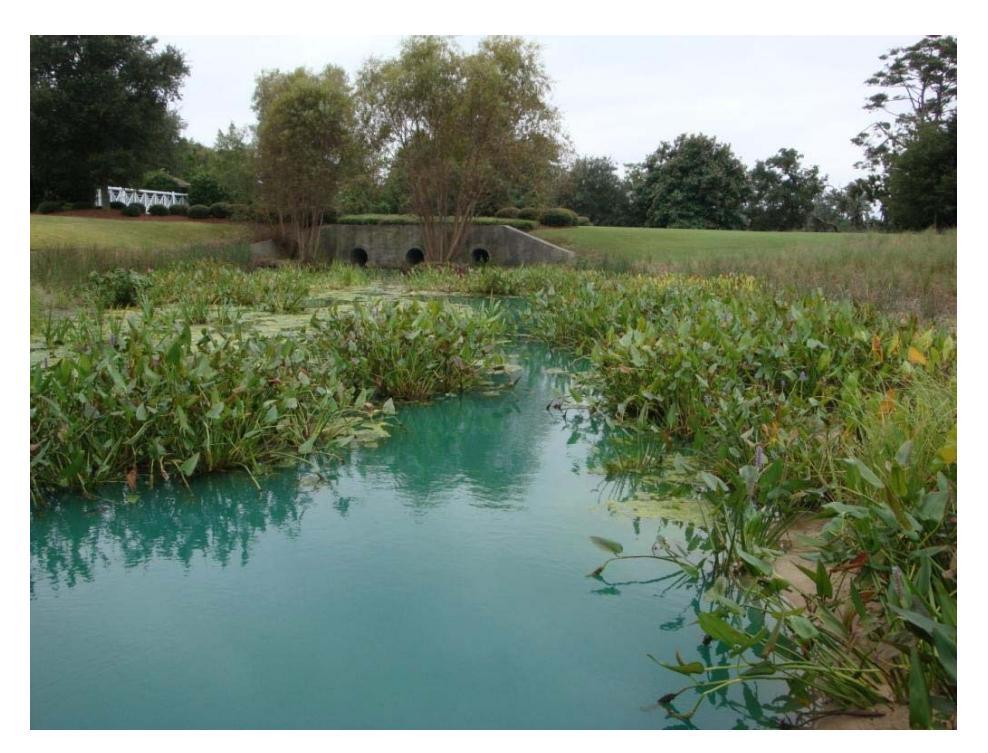
Figure C10. Stormwater wetland 4 months after planting (October 2009). Note the blue dye which is indicative of the impact of pumped water from Porters Neck Country Club

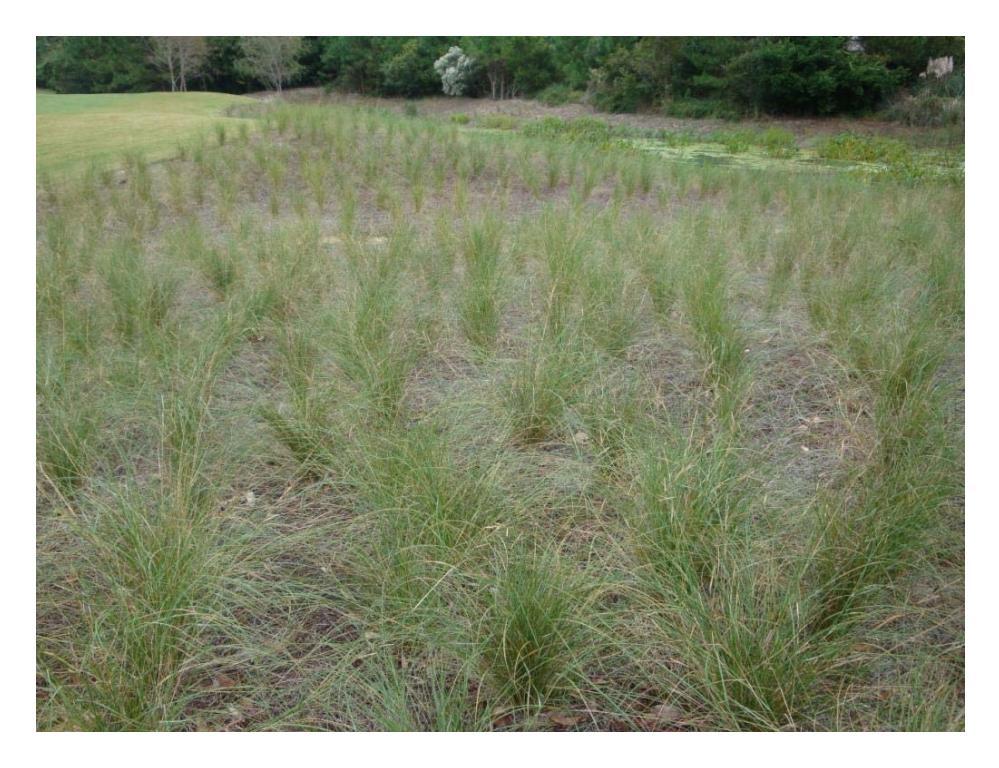
Figure C11. Stable banks four months after planting (October 2009). Planted with native *Spartina patens*.

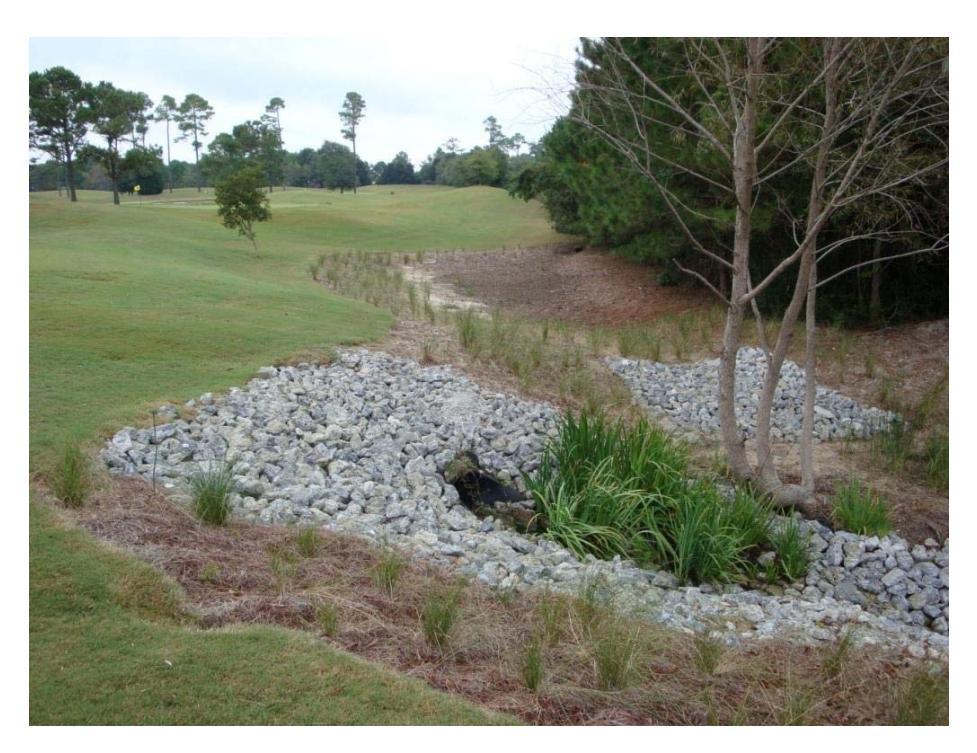
Figure C12. Wetland inlet and bioretention area (October 2009).
